SILVER CREEK WATERSHED-BASED PLAN

Illinois EPA Section 319 Financial Assistance Agreement 3191402

Illinois Environmental Protection Agency
Bureau of Water
Watershed Management Section
July 2016

**SILVER CREEK WATERSHED-BASED PLAN
RESOURCE INVENTORY**

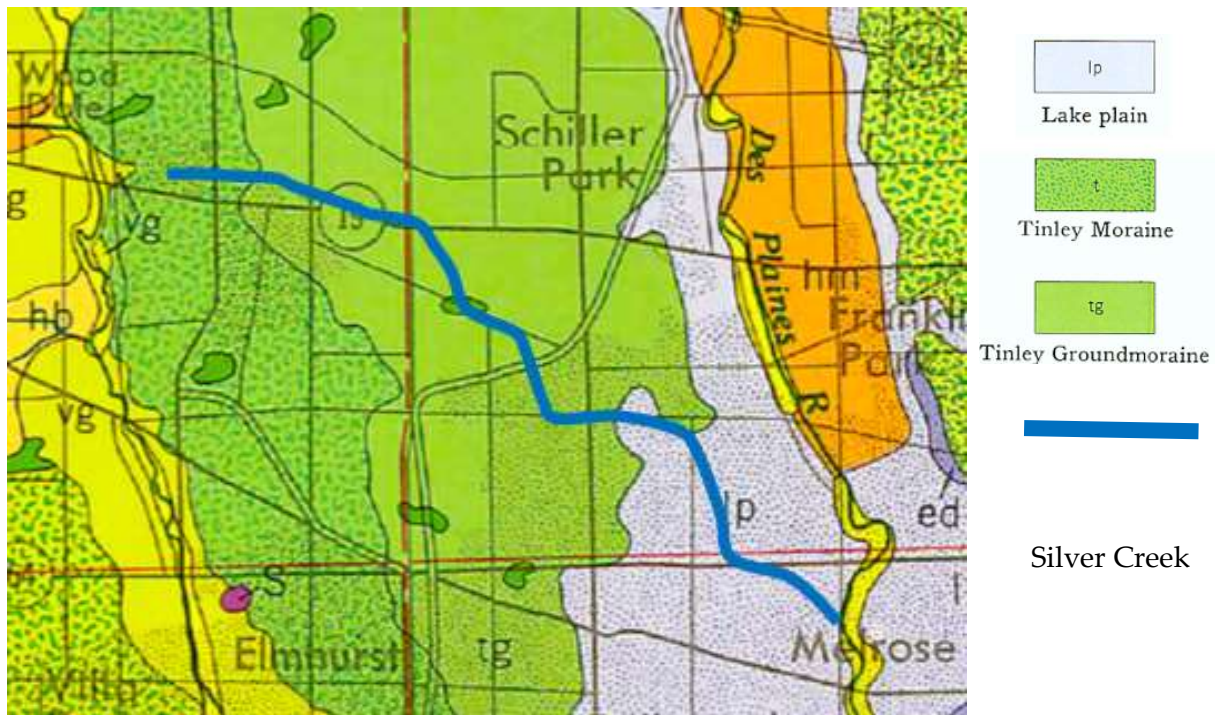
Fig. 4: Surface Geology includes lake plain (lp) to the east, and Tinley Moraine (t) / Tinley Groundmoraine (tg) to the central and west watershed areas (Willman, 1971).

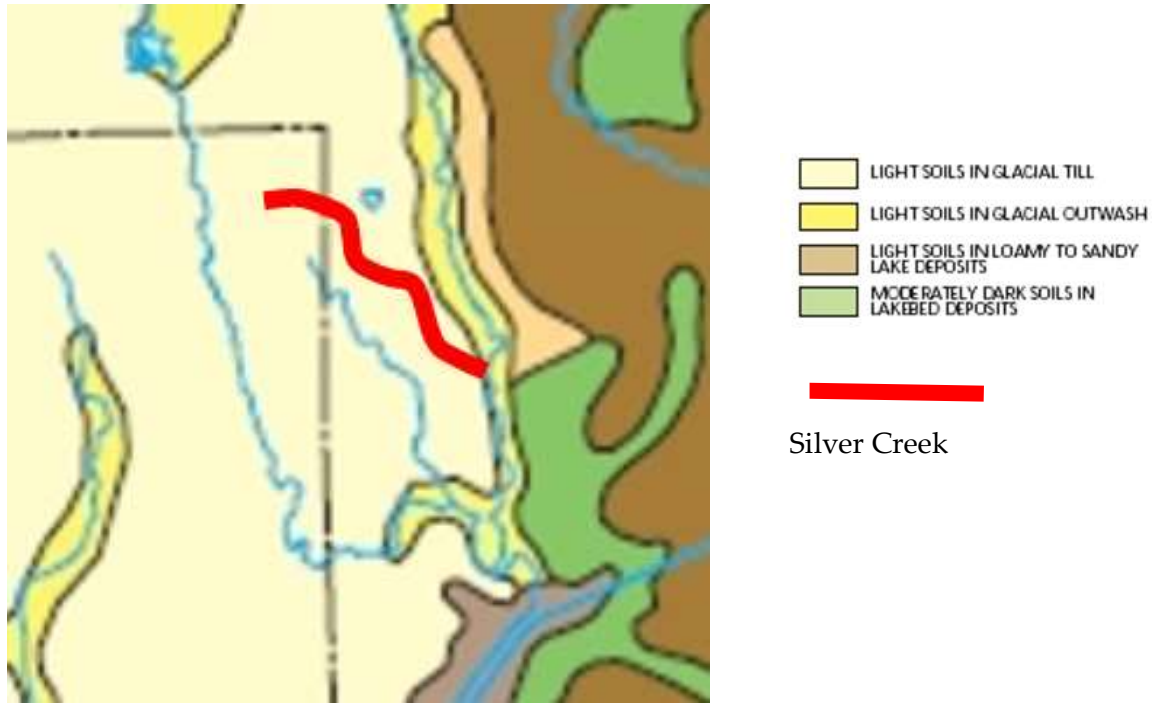
Fig. 7: Geological Deposits and Soil Lithology in the vicinity of the Silver Creek watershed (Source: Chicago Wilderness). Most Silver Creek watershed soils were formed in glacial till or glacial outwash deposits.

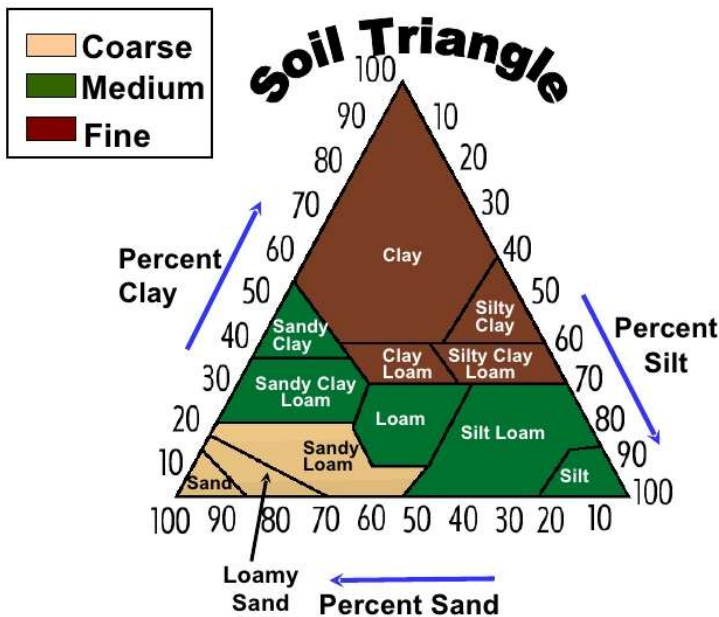
Exhibit 1: Soil classification types including loam, silt loam, silty clay, etc. vary depending on the percent silt, sand and clay present (NRCS). Most of the watershed soils present are considered “fine” soils, dominated by silt and clay components. These types of soils are noted for low to moderate rates of infiltration.

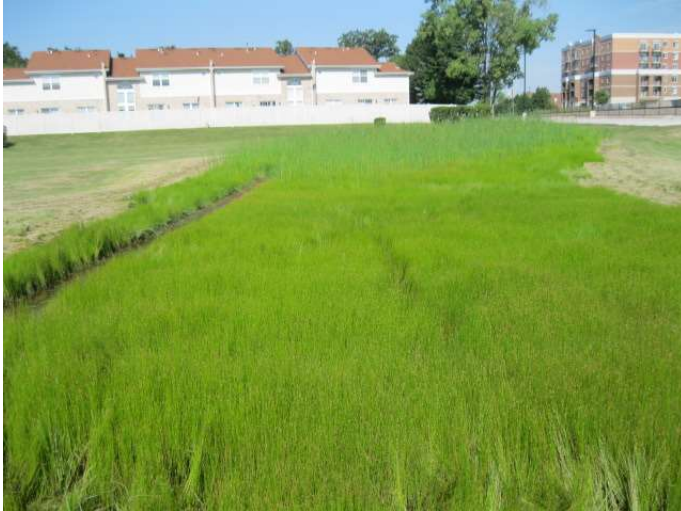
Photo 1: The farthest upstream headwaters of Silver Creek (channel at left) in Wood Dale are located within a detention facility. Examples of wetland habitat adjacent to the stream channel are lacking throughout the watershed. This area is mowed around the perimeter. But the central area perhaps was too wet to be mowed at the time of this photo.

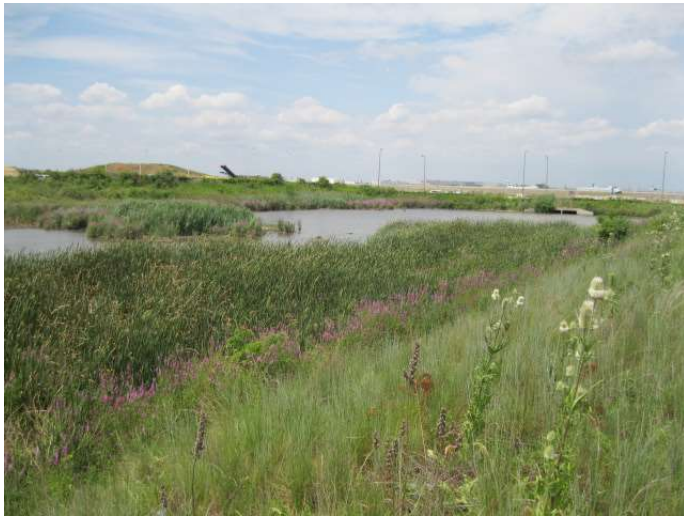
Photo 2: Wetland mitigation area along Silver Creek. This wetland area is located north of Thorndale Avenue in the O'Hare Airport vicinity.

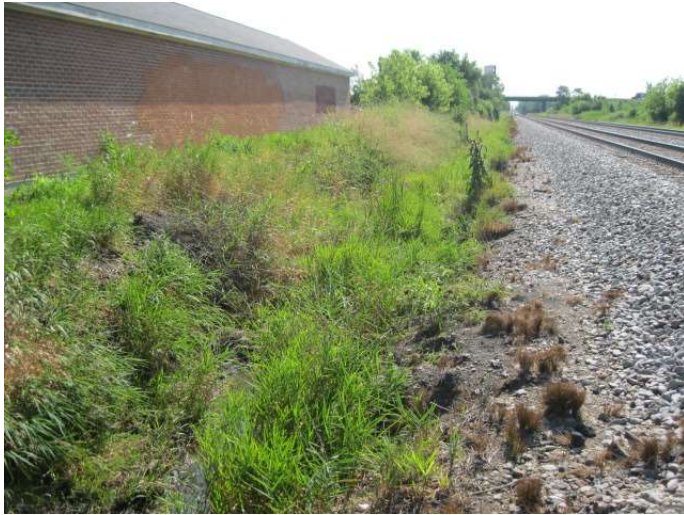
Photo 2: Transportation land use such as railroad, road, and O'Hare airport along with commercial / industrial development have heavily impacted Silver Creek. Here, the far upstream headwaters are channelized in a narrow corridor between these two land uses.

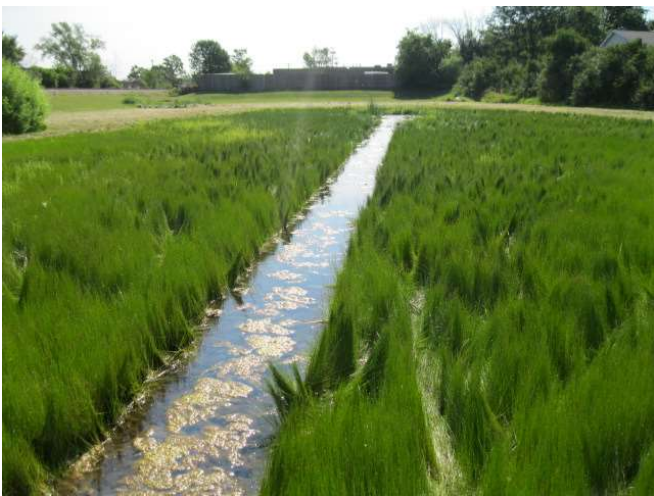
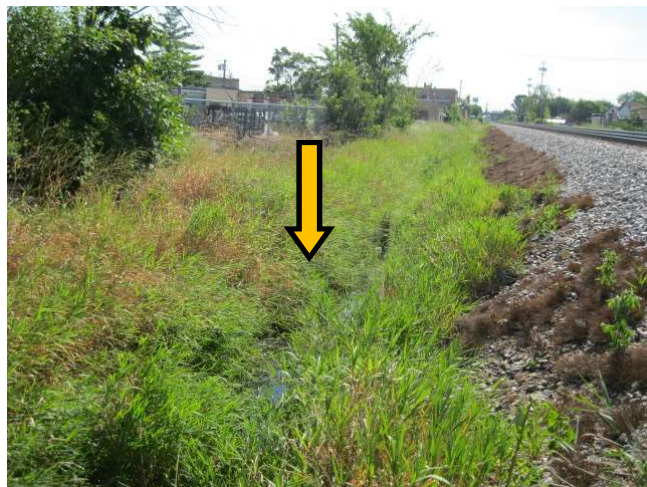
Photos 3 and 4: The farthest upstream Reach # 1 headwaters of Silver Creek within a detention facility. Wetland vegetation adjacent to the channelized ditch helps to reduce pollutant loading from adjacent residential and mowed turf areas. Farther downstream (right photo), Reach # 1 remains highly channelized, likely with intermittent flow, adjacent to railroad tracks located south of Irving Park Road and west of Rt. 83. Small pockets of water contains frogs, ducks, and other wildlife in the area.

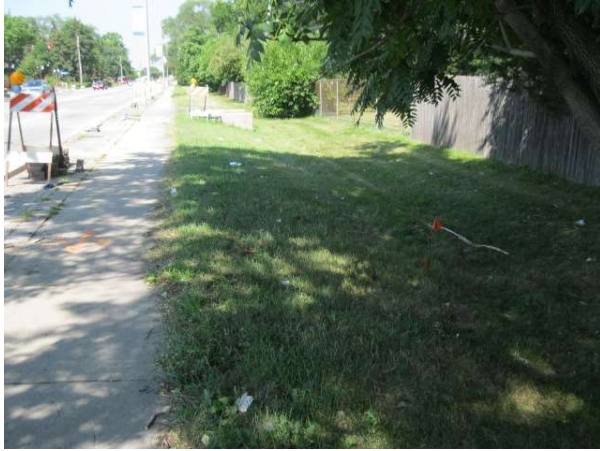
Photo 5: Reach # 2 is piped below ground alongside Irving Park Road.

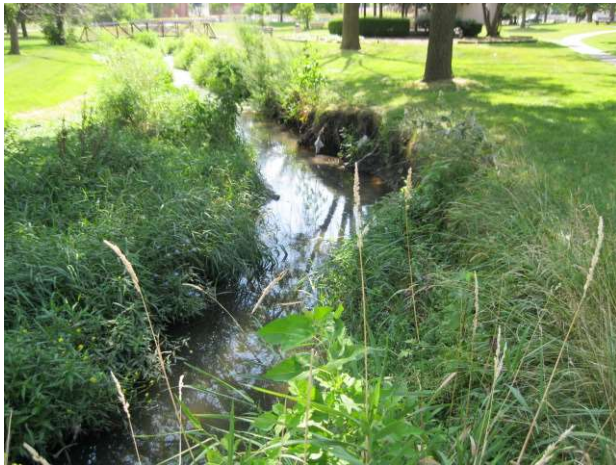
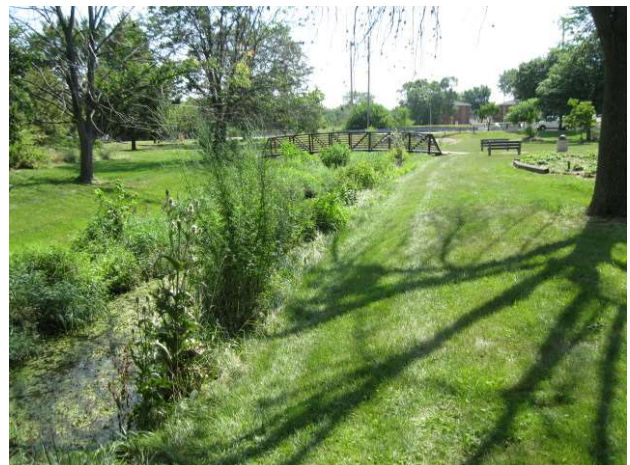
In Reach # 3.1, the creek daylights downstream of Irving Park Road in Bensenville into a park setting. Approximately 20% of the 588 LF length of Reach # 3.1 contains severe streambank erosion.

Photo 6 (left): Silver Creek is above ground in Bensenville beginning immediately south of Irving Park Road. Reach # 3.1 (and Reach # 3.2 described below) contains some of the largest non-developed vegetated buffer along located along Silver Creek. Some areas contain severe stream bank erosion. Invasive reed canarygrass occurs immediately along the channel. But the dominant riparian vegetation is turf grass, which is known to contribute significant pollutant loading. Turf grass is also problematic for stream enhancement because it does not effectively stabilize eroding banks. Photo 7 (right): The existing park area contains significant existing amenities, as well as opportunities for streamside BMPs and channel enhancement.

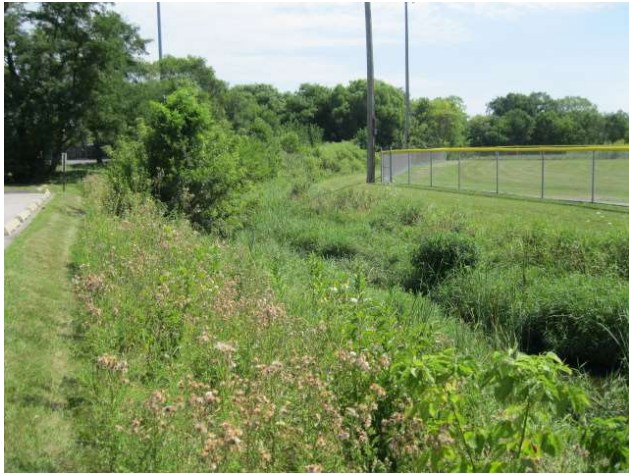
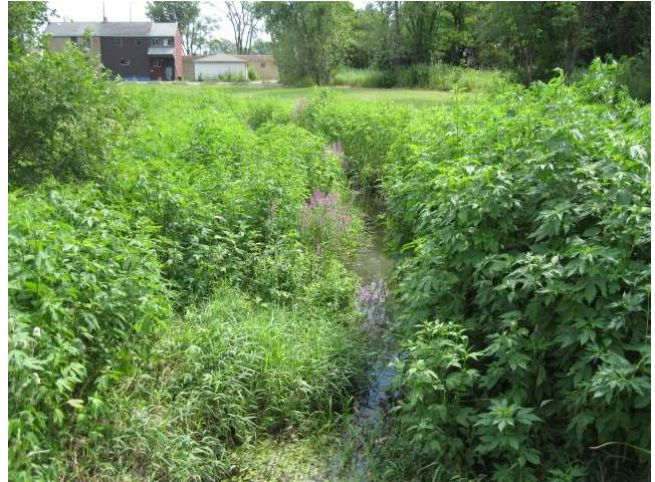
Reach # 3.2 (as with Reach # 3.1) continues to contain a relatively wider vegetated riparian buffer along Silver Creek. Open space is adjacent to the stream channel in nearly all areas. Approximately 35% of Reach # 3.2 is moderately eroded. This reach contains three detention basins.

Photos 8 and 9: A continued primarily vegetated riparian buffer occurs through Reach # 3.2. Some moderate erosion occurs. Vegetation is primarily invasive species and bank heights are relatively tall. Three detention areas occur through this 1,425 LF long stream reach.

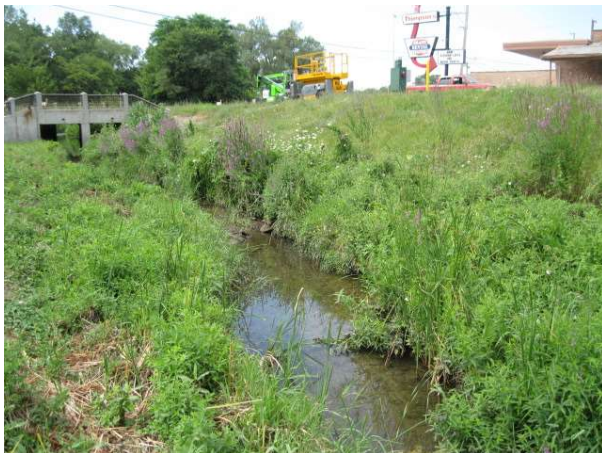
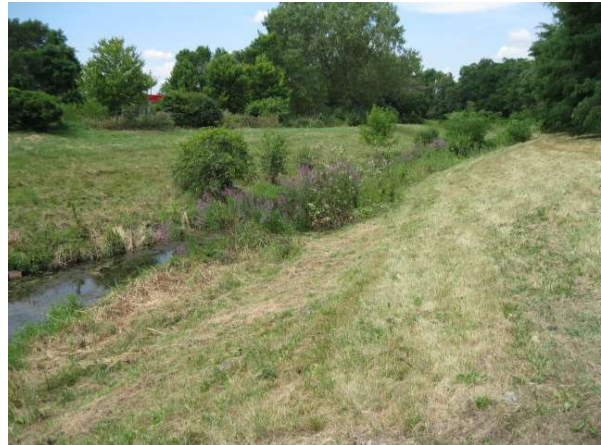
Reach # 4 contains consistent characteristics throughout its length between Mason Street and York Road. The creek is relatively incised, with tall banks. Consistent side slopes occur. Most of the riparian vegetation is mowed. But a narrow non-mowed area with a mixture of native and non-native vegetation occurs within several feet on each side of the creek.

Photos 10 and 11: Reach # 4 contains a wide, excavated creek area with tall banks and extensive mowed vegetation.

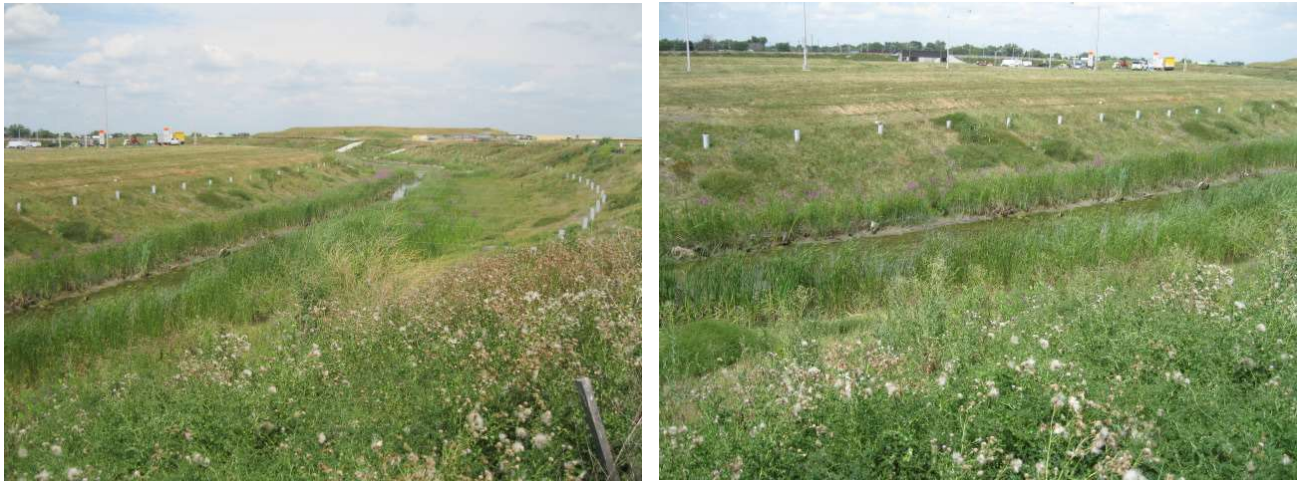
Photos 12 and 13: The excavated channel in Reach # 5 is relatively wide. Reduced baseflow velocities appear to support invasive wetland vegetation include cattails. Beyond the lower channel banks, extensive areas of mowed vegetation (turf grass or fescue and other meadow grass) occurs. It is likely that water quality issues in this vicinity may be more related to excessive sedimentation or deposition (related to an over-widened baseflow channel) rather than bank scouring (photos taken off South Access Road).

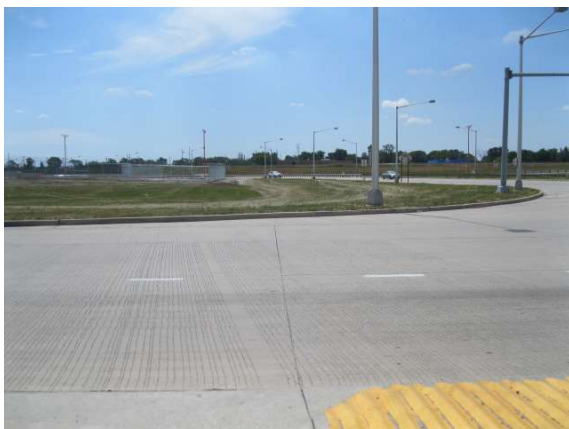
Photo 14: Silver Creek below ground for 0.71 miles of creek length.

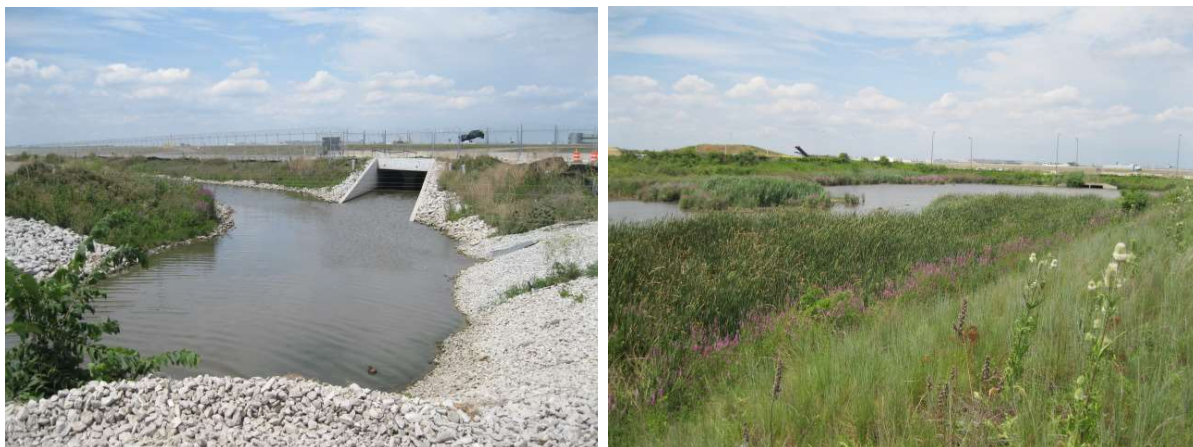
Photos 15 and 16: Silver Creek in Reach # 6 appears to have been converted into more of a runoff storage facility. West of Taft Road (left photo) the channel is rock-lined near the toe of slope. East of Taft Road (right photo) an on-line detention area occurs with cattails and Phragmites along the creek channel. With a very wide channel, sediment deposition is likely extensive. However, emergent wetland vegetation would act to reduce or mitigate some water quality impacts.

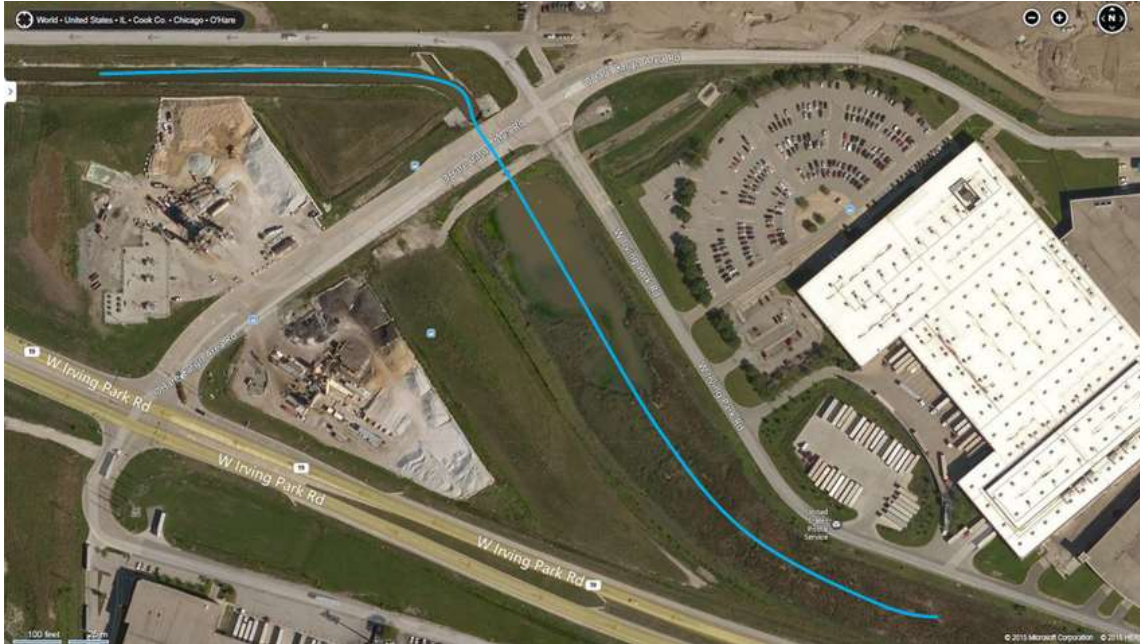
Exhibit 2: Silver Creek in Reach # 6 was converted into a broad, shallow detention area with extensive adjacent emergent wetland dominated by cattails. It is assumed that maximized flood storage capacity is a primary purpose for the broad configuration of this detention area.

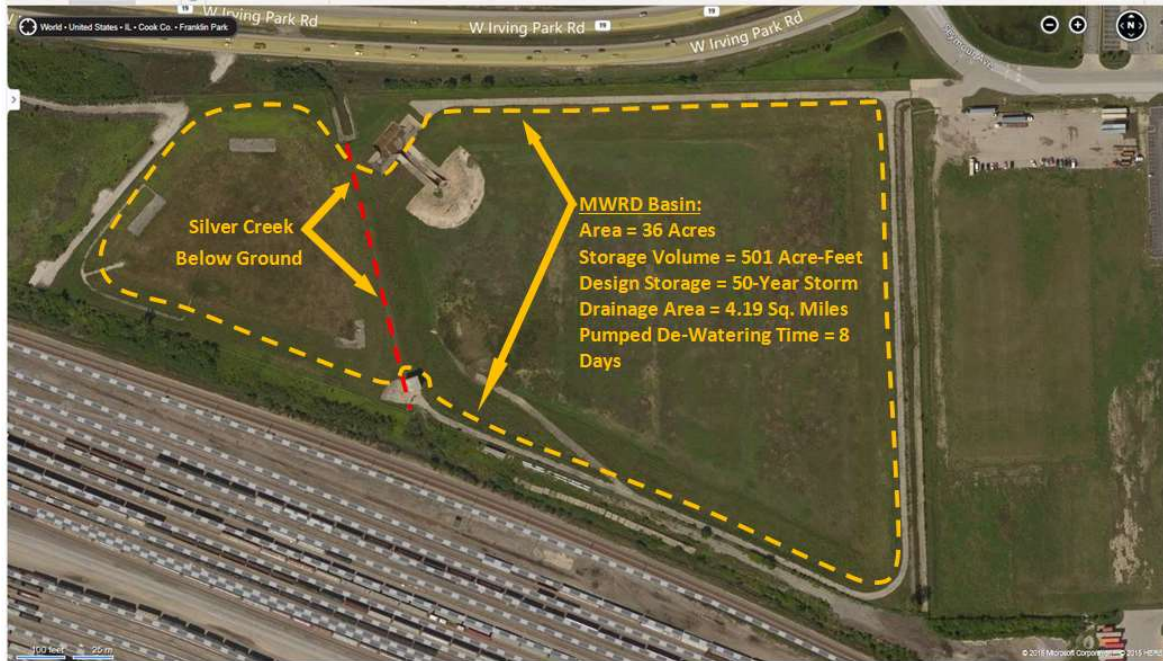
South of Irving Park Road, Silver Creek is piped underground 700 LF as the channel flows south through a constructed MWRD Basin Area. The channel elevation is relatively high, while the basin bottom extends approximately 25 ft below Silver Creek. The Basin is depicted below. There are few ongoing water quality benefits for Silver Creek associated with the basin as currently operational. Between 2007 and mid-2015, Silver Creek has only flowed into the basin on 18 events (just over 2 events per year on average).

Photo 17: MWRD Flood Storage basin along Silver Creek located immediately south of O'Hare Airport (off Seymour Road). The MWRD Basin has an extensive runoff storage volume (501 acre-feet). However, Silver Creek is piped below ground (in a 60-inch culvert) over 700 LF along the site. Silver Creek overflows into the Basin (from the north) only during extreme flood events.

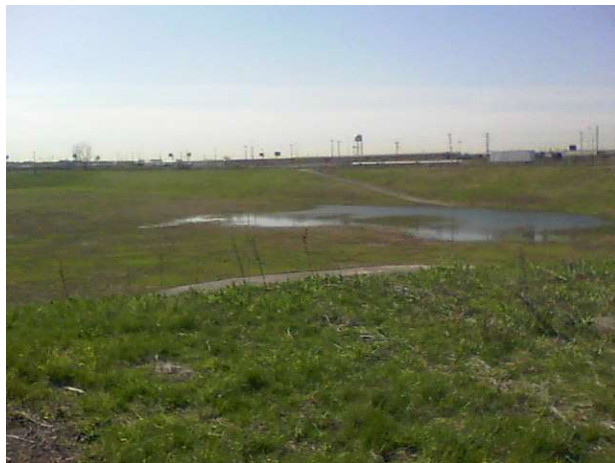
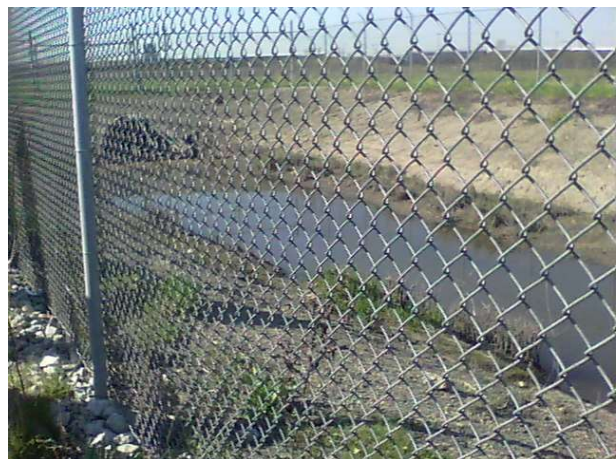
Photos 18 and 19: The MWRD Basin (left photo) contains some surface water storage at the bottom of the facility. The facility is overall managed to be pumped relatively dry. Mowed turf grass is dominant along the tall side slopes of the 36-acre facility. Silver Creek (right photo) flows below ground and does not interface with the MWRD Basin except during extreme flood events. Both facility modifications and operational modifications would be needed in order for the existing basin configuration to be allowed to provide improved water quality benefits along Silver Creek.

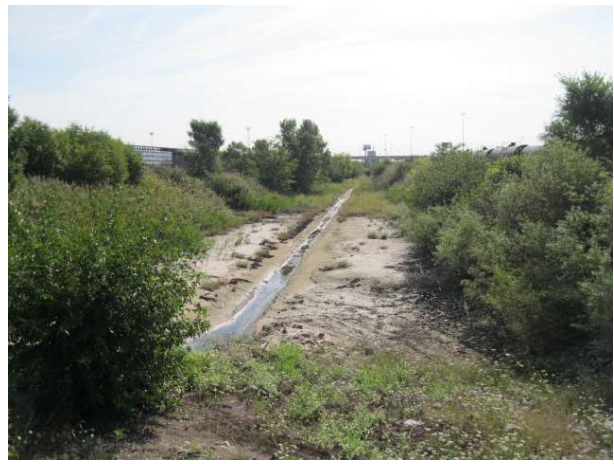
Photos 20 and 21: The Canadian Pacific railroad yard in Franklin Park contains railroad facilities underlain by gravel with some storm pipe drainage. One surface pond is maintained at the site. Otherwise, Silver Creek is piped below ground at the facility. The small basin (right photo, facing east) collects piped subsurface flow. It is pumped out during flood events and discharged into Silver Creek. The basin appears to be capable of only minor water quality improvement.

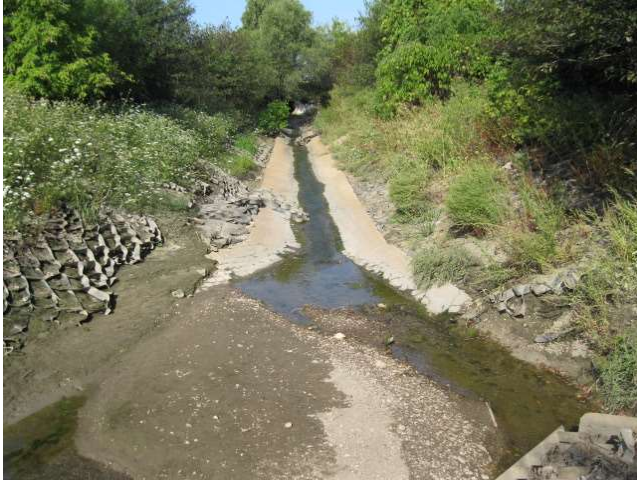
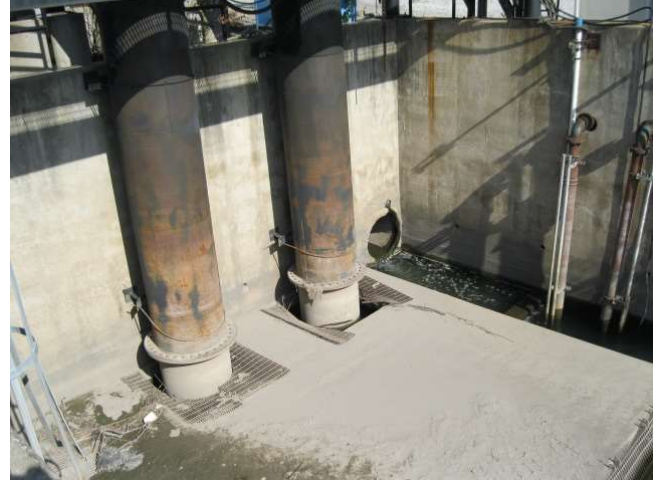
Photos 22 and 23: The small runoff collection basin receives storm pipe inflow from the railroad yard. During major flood events, flood waters are not detained long, but are pumped out with large capacity overhead pumps (right photo) into Silver Creek when the flood stage recedes.

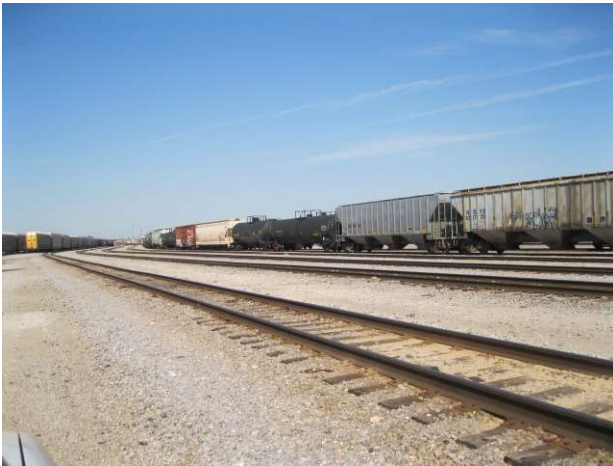
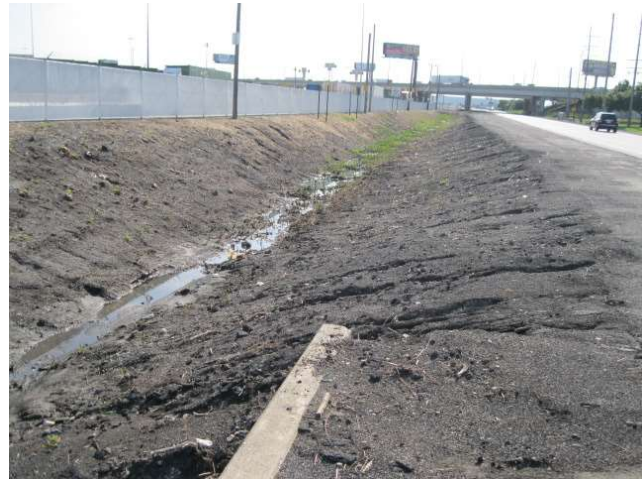
Photos 24 and 25: The Canadian Pacific railroad yard reach contains extensive gravel areas (left photo). The gravel materials improve potential runoff infiltration, provides at least limited filtering of oil, grease, or other materials, and reduces potential runoff volume into Silver Creek. The south parcel of the railroad yard contains office building, parking, and other impervious surfaces. Perhaps the most significant concern (and opportunity for water quality improvement) is the ditch approximately 4,500 LF in length along Franklin Avenue. This non-vegetated ditch contains significant bank erosion, rills, and gullies. During the site visit, vegetated along the ditch was being herbicided (we are uncertain if rock improvement is being proposed along the ditch.) Sediment deposits in the channel bottom are extensive. This ditch is periodically dredged to remove sediment deposits.

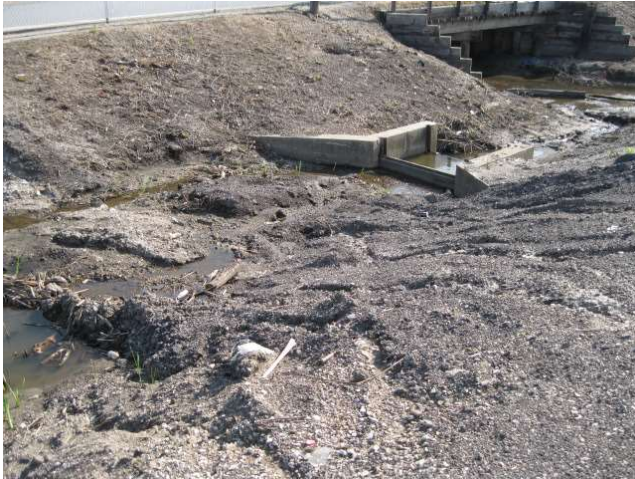
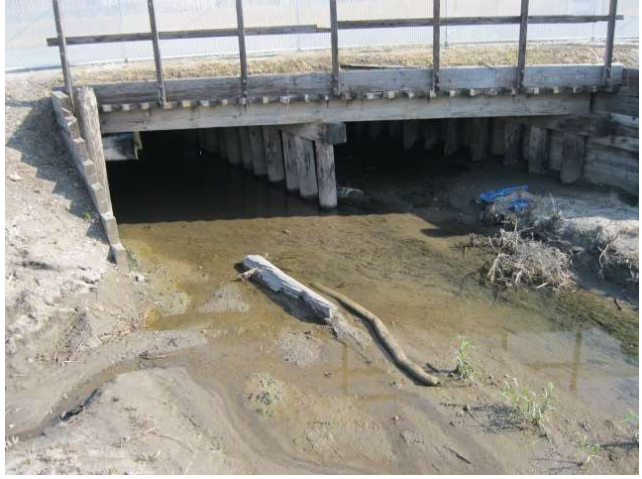
Photos 26 and 27: Sediment deposits at the downstream end of the CP Railroad Ditch along Franklin Avenue, near Silver Creek. A ditch check has been installed, but non-vegetated banks contribute significant sediment loads. Right Photo: Sediment deposits in Silver Creek as it emerges from below-ground through the CP Railroad. It should be noted that not all sediment deposits depicted emanate from the CP facility. The fact that the creek is piped below ground implies that all sediment from upstream areas is also conveyed through the site. Such sediment from onsite and from upstream becomes deposited as soon as the creek width widens out enough to reduce velocities and allow for sediment deposition.

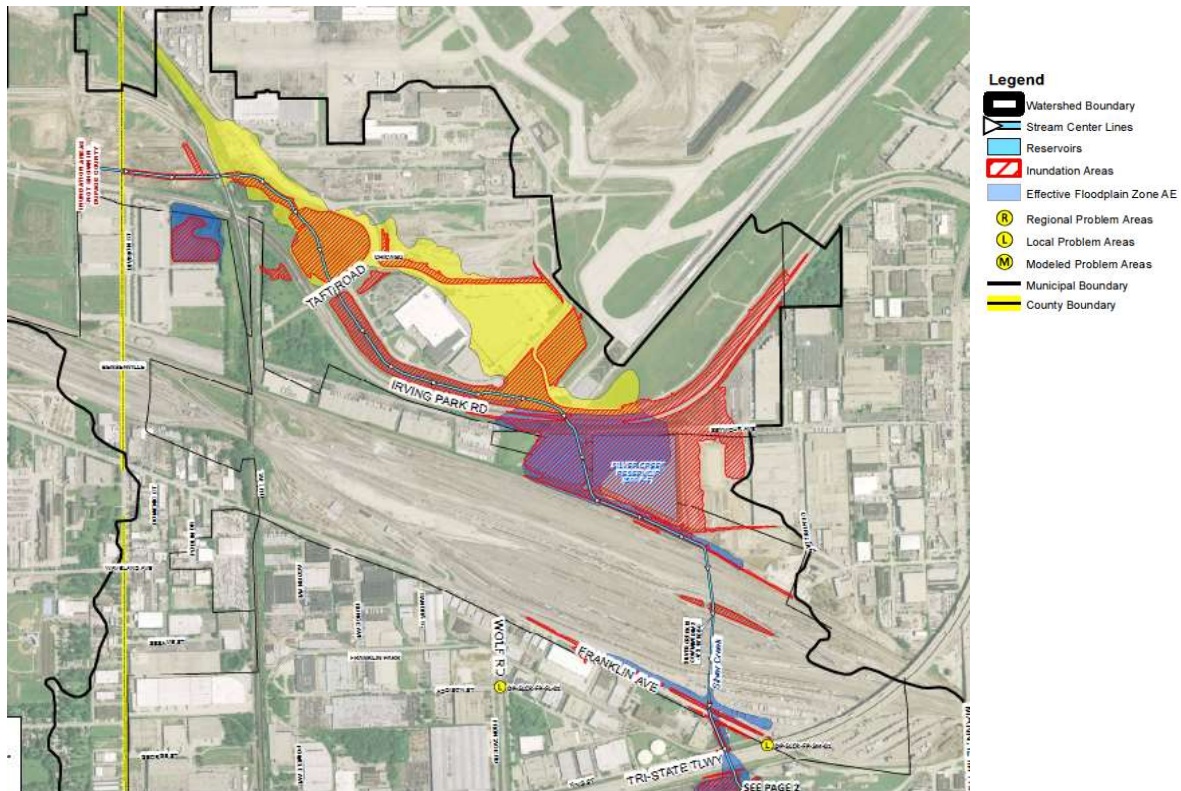
Exhibit 3: MWRD Flood Study (2010) in the Cook County portion of the Upper Watershed of Silver Creek between Division Street and I-294 near Franklin Avenue. (Note: The MWRD watershed boundary depicted is no longer applicable; See Fig. 2.)

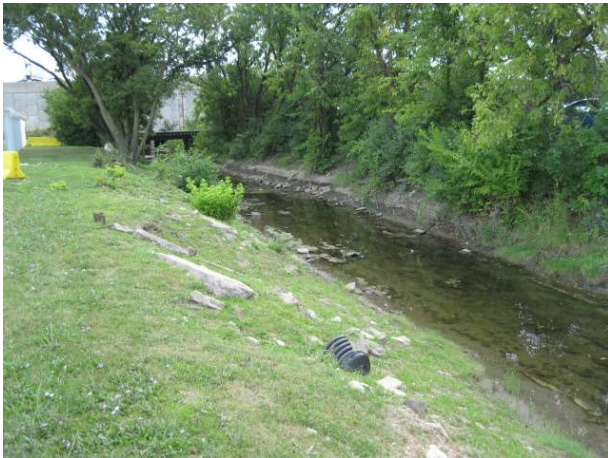
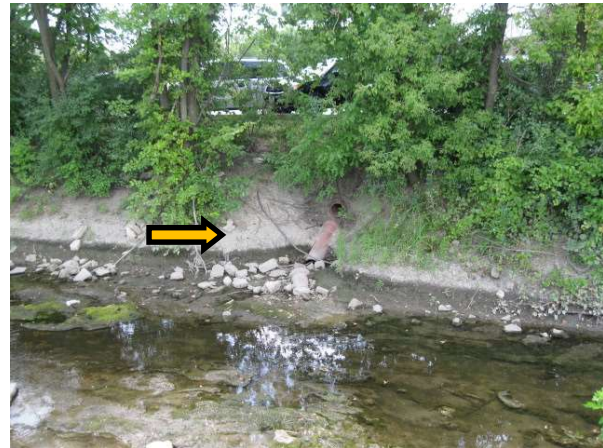
Reach # 9 begins south of Franklin Avenue. This reach contained significant qualitative observations of water quality impacts. Channel sedimentation appeared to be high in some areas. (This was confirmed with sediment upstream described in Reach # 8.) Flow constriction contributing to extended inundation may be an issue, although no readily detected dam or

impoundment structures have been observed to date. Algae growth was also high, indicating nutrient loads are significant. Bank erosion along the toe and middle slope areas of the steeper west bank were evident. Other than Reach # 3.1, this was the first area that had extensive bank erosion. The east side of Silver Creek includes a large industrial tank farm area, Magellan Pipeline. Numerous safety / spill control features were observed around the tank areas. Magellan holds 6 NPDES permits which regulate xylene, BOD, ethylbenzene, total phenols, benzene, and oil and grease. However, no discharge of these pollutants was reported. It would appear that the NPDES permit may be in the event of certain potential circumstances (perhaps including catastrophic flooding) that could result in the discharge of such pollutants. As a general note, the vegetation at the Magellan facility is dominated by extensive areas of mowed turf grass. As stated previously, mowed turf grasses can contribute nutrient discharge into Silver Creek. Turf grasses also have weak root structures which do a poor job of protecting streambanks from erosion.

Photos 28 and 29: The upstream end of Reach # 9 can be described as a marked change in channel characteristics and water quality impacts compared with upstream areas. For instance, sedimentation was more apparent even though no online impoundment structure was observed (left photo). Algae growth was also high. Also, lower and middle bank slopes had low levels of vegetative coverage (right photo). Channel conditions including lack of lower channel vegetation and sedimentation deposits are indicative of persistent, long-term inundation. (Lack of bank vegetation continued downstream through Reach # 10.)

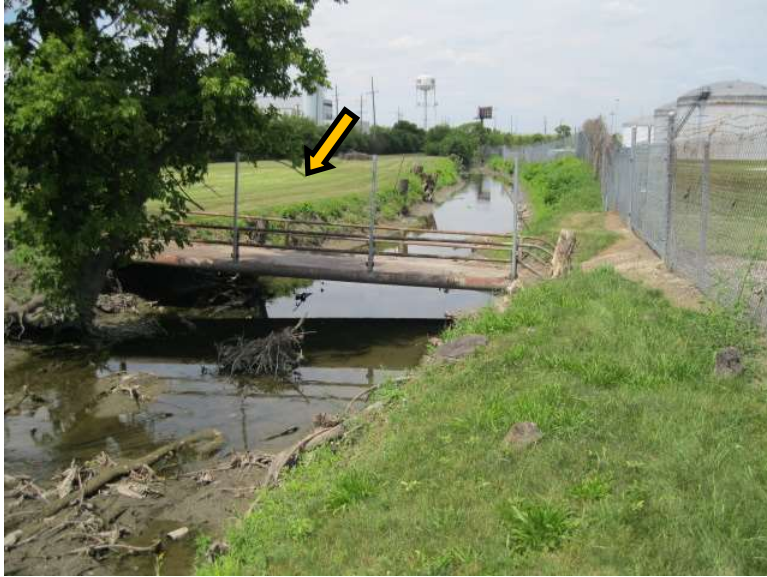
Photo 30: The downstream area of Reach # 9 located north of Belmont Avenue, immediately west of an industrial tank farm. This area contains a broad, linear, mowed riparian side channel (left side of photo) that could be converted into a significant water quality improvement feature to enhance Silver Creek.

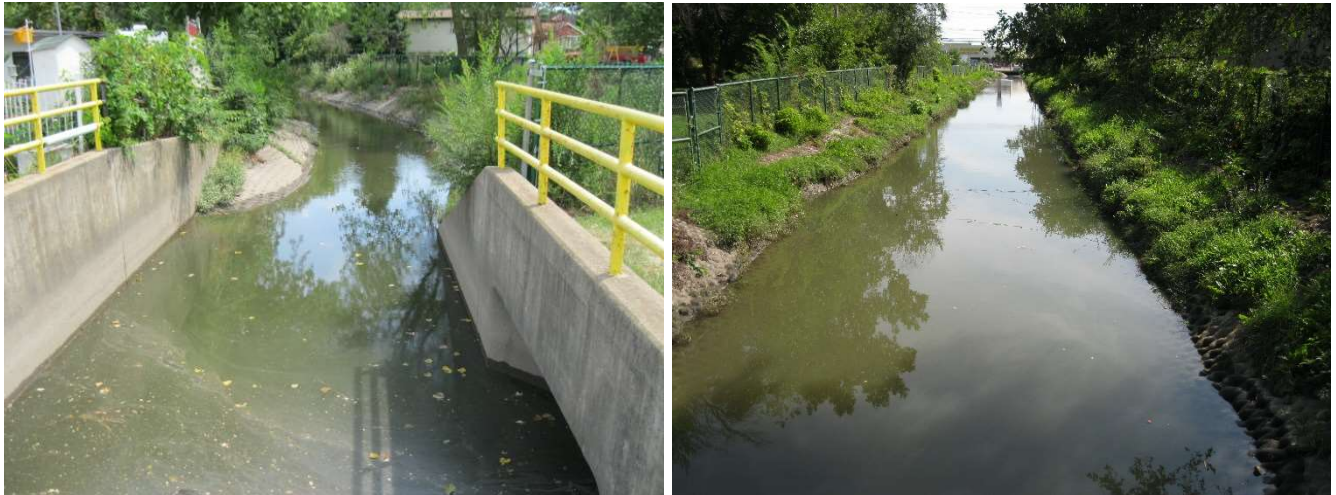
Photos 33 and 34: Runoff from Grand Avenue (left photo) includes accumulations of oil, grease, scum, and solids (left photo). Throughout this reach, Silver Creek is fenced, perhaps for resident safety. It is likely that flood flow velocities are high. Partially vegetated concrete revetments are on all bank areas. Bank heights are relatively low, but riparian conditions include residential encroachment directly at the overbank area. Resident flooding concerns appear to be extensive.

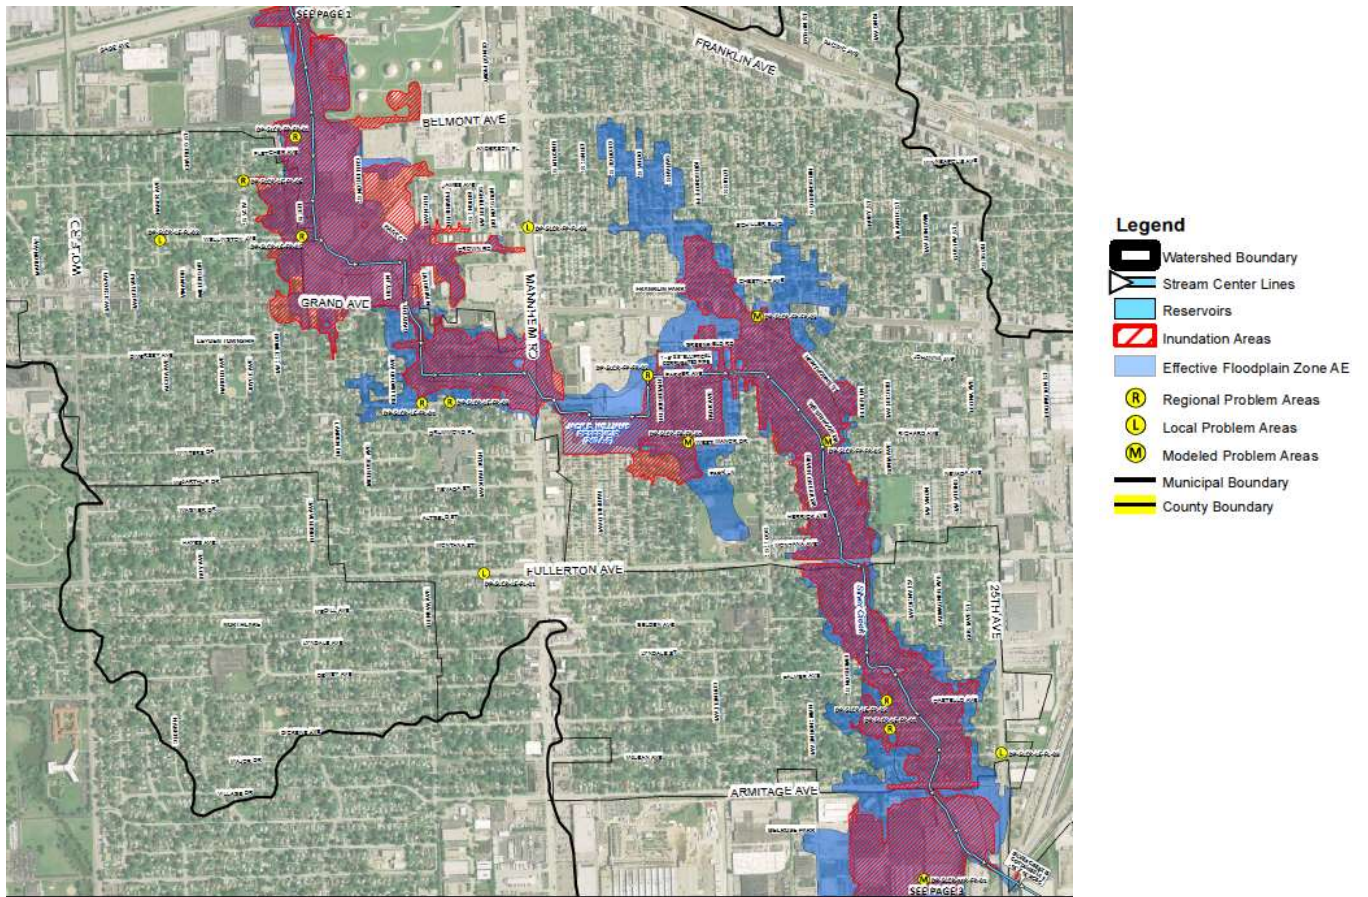
Exhibit 6: MWRD Flood Study (2010) depicting the Central Watershed Area between Belmont Avenue and Armitage Avenue. (Note: The MWRD watershed boundary depicted has been modified in areas; See Fig. 2). The extent of flood-related problems in the central watershed near the channel is extensive. There is a lack of near-channel runoff storage. Development encroachment and extensive impervious surfaces, including within the floodplain likely contribute to flooding impacts.

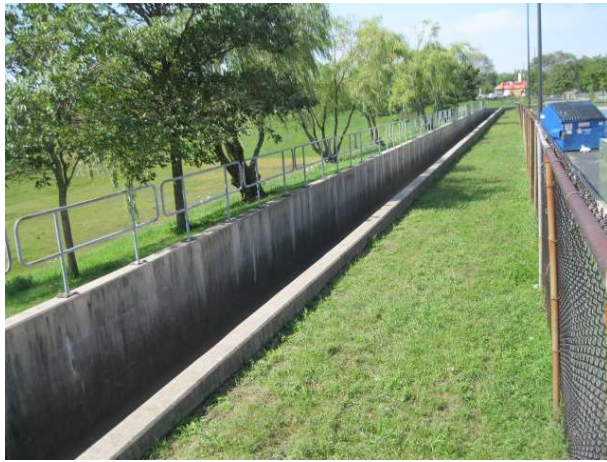
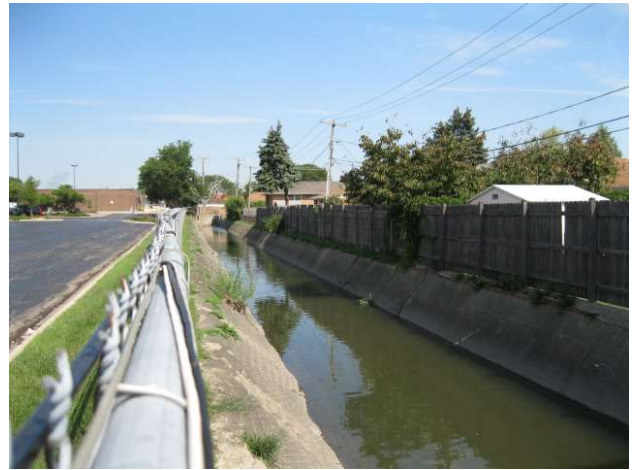
Photos 35 and 36: Channel alignment includes vertical concrete banks, and concrete sloped banks. Such highly engineered approaches to channel management provide no pollutant filtration or pollutant reduction. Washoff from extensive adjacent mall parking areas is also piped directly into the stream. A high percent of pollutants in the channel are then confined in the channel, and/or washed downstream in the next runoff event. These conditions also raise water temperatures in the channel, further diminishing site suitability for aquatic life.

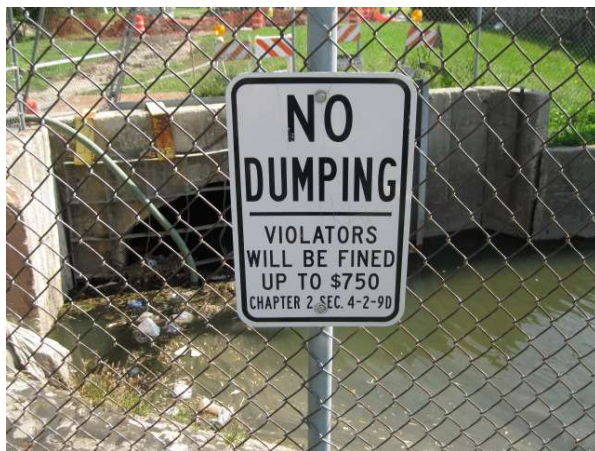
Photo 37: Reach 12 has a trash rack and fencing to prevent dumping. With underground piping, debris can block flow conveyance and contribute to adjacent flood impacts.

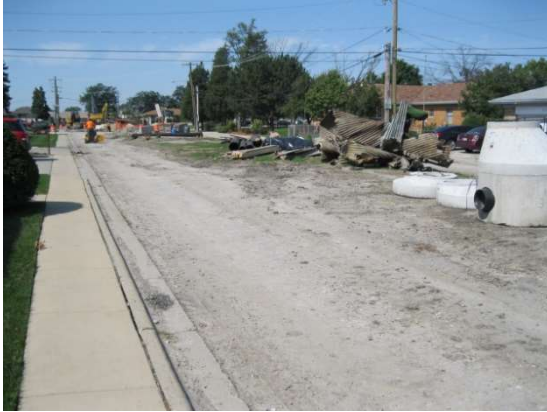
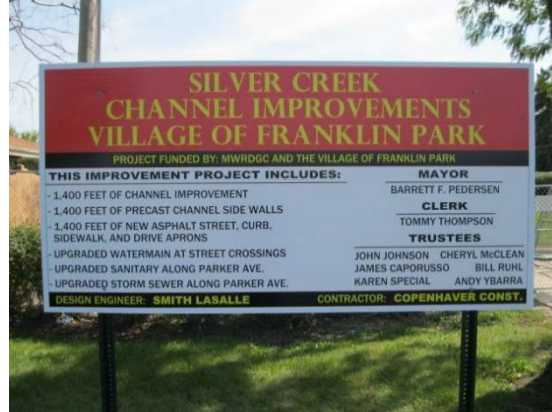
Photos 38 and 39: Recent channel improvements may daylight the creek channel in areas where it is currently below ground (left photo). But the resulting channel and riparian conditions include 100% impervious surfaces (see Photo 40).

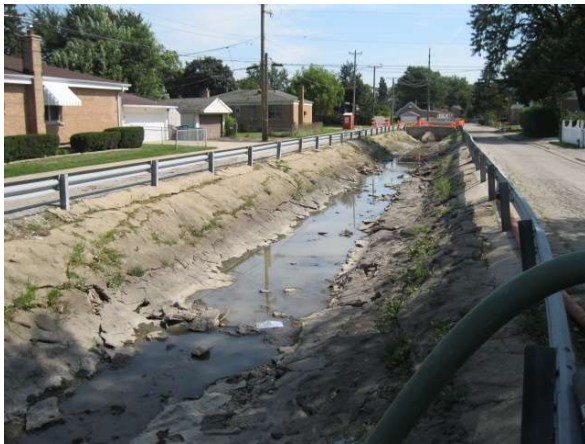
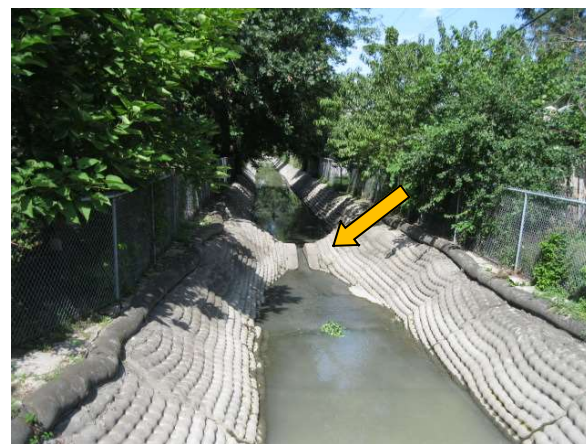
Photos 40 and 41: Reach 13 channel conditions include street paving and concrete placement directly within and alongside the creek channel. Proposed changes to the existing condition appear to include vertical retaining walls and hard armoring. These modifications appear to be designed for slightly increased flood storage, and/or conveyance of flood waters and will likely provide little to no benefit in improving potential water quality or aquatic habitat. Right photo: Typical and extensive concrete revetment conditions along residential areas throughout Reach 9. Flow restrictor structures (see arrow) approximately 1.5 feet high, occur in several areas. These structures may in part be designed to reduce otherwise potentially very high runoff velocities and associated scouring through the reach.

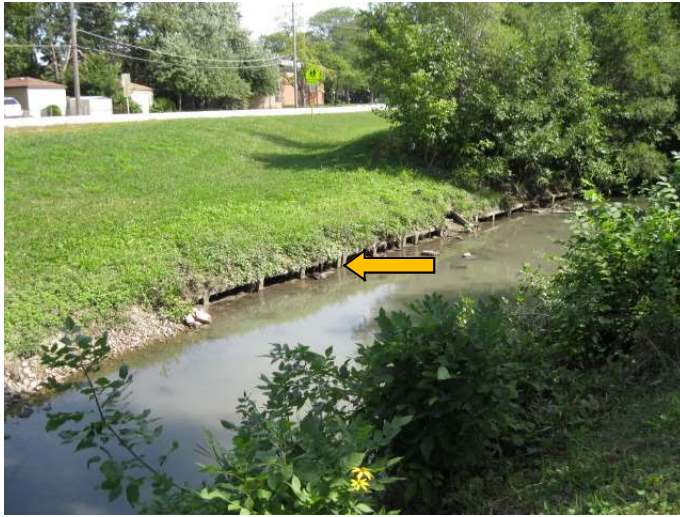
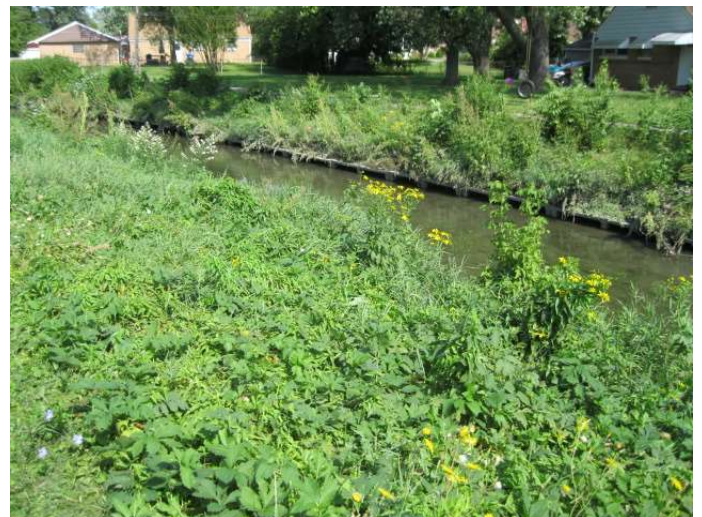
Photos 42 and 43: Reach 14 contains vegetated banks, and occasional native planting areas. However, turf grasses dominate most of the bank vegetative condition

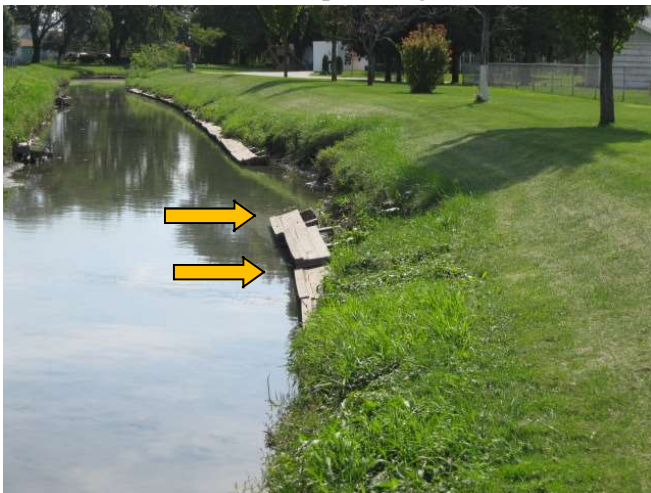
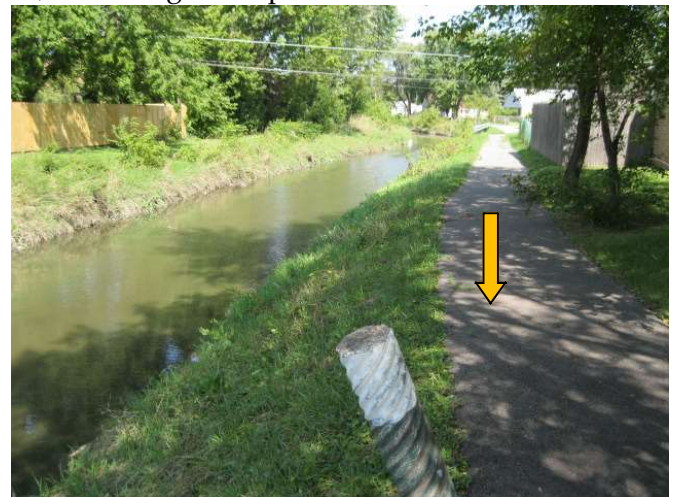
Photos 44 and 45: In some locations, lunker boxes are highly scoured. Turf grasses predominate. Right Photo: Interestingly, a side-channel walking path, the "Silver Creek Trail," allows residents to view the open stream channel condition.
