SILVER CREEK WATERSHED-BASED PLAN

Illinois EPA Section 319 Financial Assistance Agreement 3191402

Illinois Environmental Protection Agency
Bureau of Water
Watershed Management Section
July 2016

**SILVER CREEK WATERSHED-BASED PLAN
RESOURCE INVENTORY**

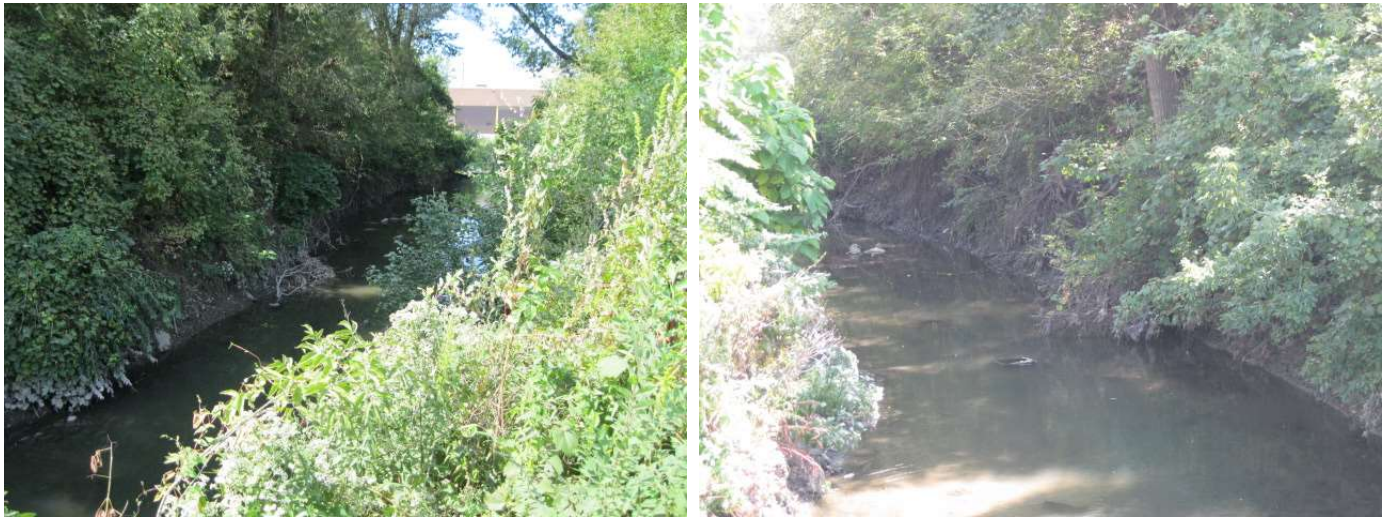
Photos 46 and 47: Creek banks are tall and relatively scoured adjacent to industrial areas.

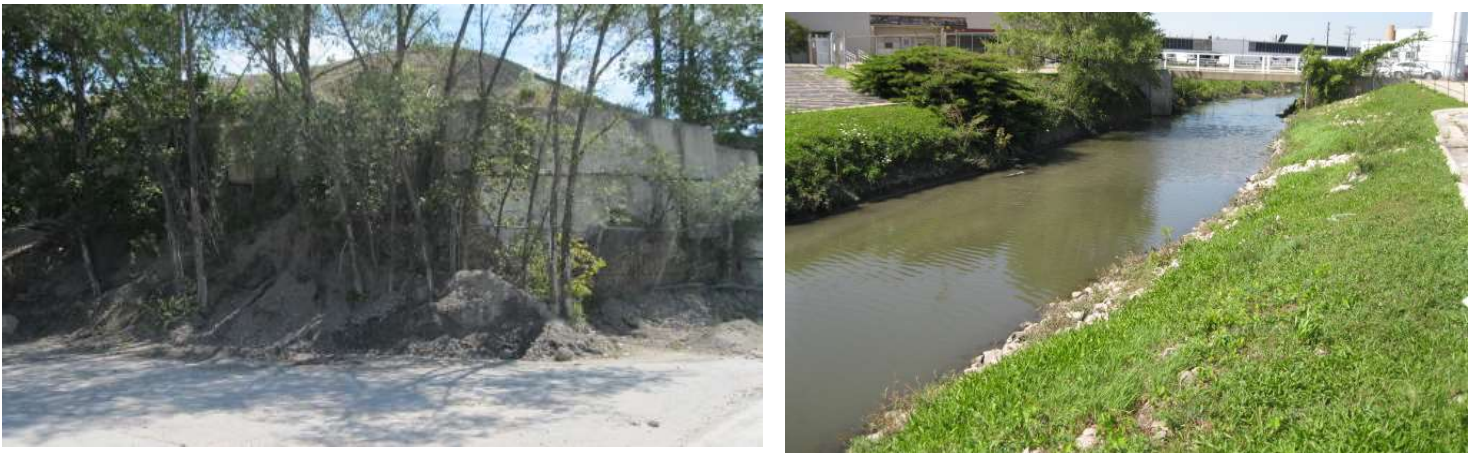
Photos 48 and 49: Industrial storage near the materials processing plant is not all contained, and is being deposited along Indian Boundary Road. This site is located immediately adjacent to the creek area. Right Photo: The creek is daylighted north of North Avenue. Mowed turf grasses predominate on the banks. The broader creek channel width has facilitated the deposition of sediment. This site attracts a Canada Goose population, perhaps in part due to feeding activities as well as the mowed turf grass. (Geese are not seen just downstream where woody vegetation occurs on the banks.)

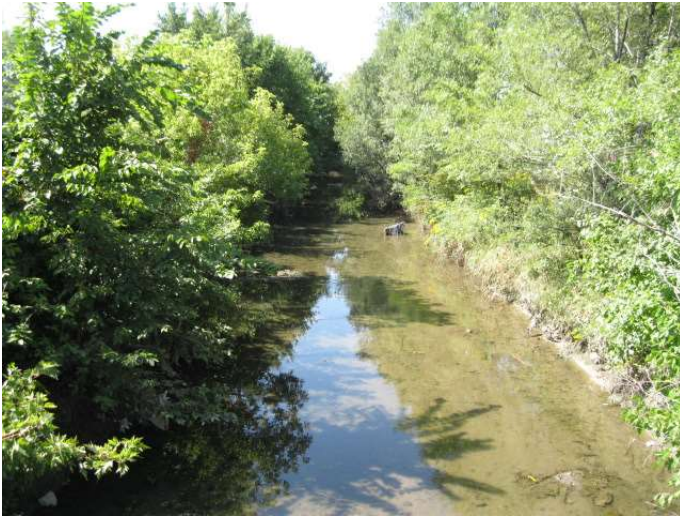
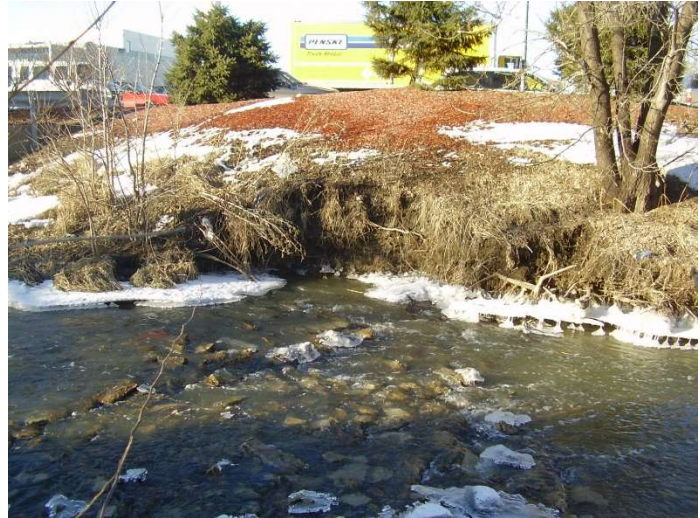
Photos 50 and 51: Vegetated streambanks along North Avenue. Riffle structures occur in areas with slightly higher channel gradients.

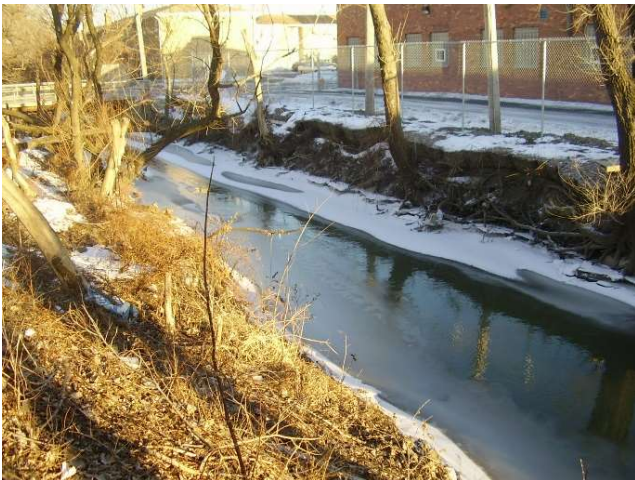
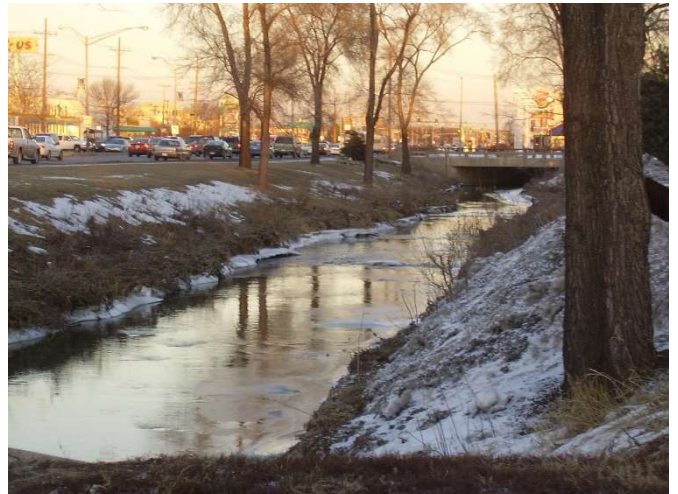
Photos 52 and 53: Industrial and parking lot encroachment impacts occur in the downstream reach. The channel is also enclosed below ground in one commercial parcel. The Illinois EPA Intensive Basin Monitoring Site on Silver Creek is located in this vicinity. Right: Open space adjacent to the creek is limited along North Avenue. In areas like these near residential sites, pet waste deposits can be common due to a lack of adjacent open space for pet walking. Dog waste bags can remind the public to dispose of pet waste.

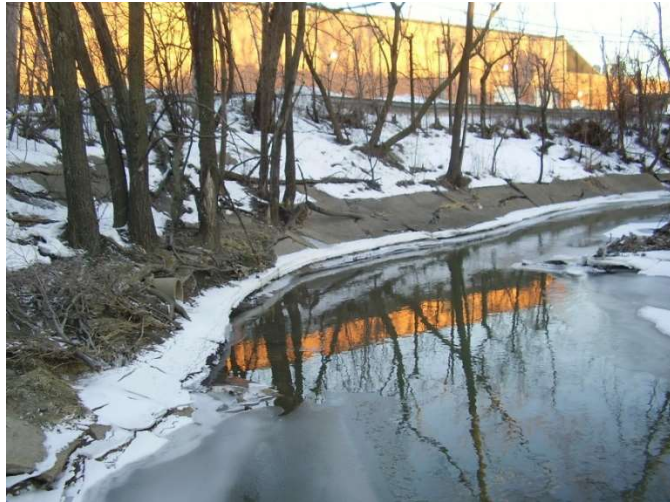
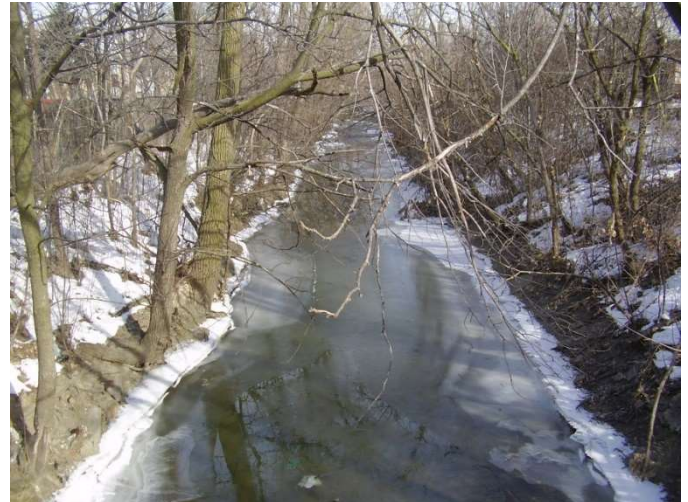
Photos 54 and 55: In areas where channelization includes 90-degree channel bends, the banks have been modified with concrete armor (left photo). Since installation, the concrete is cracked in many locations and vegetation is growing through the openings. For water quality, such a condition is more beneficial than concrete alone. Root structures can help to further stabilize banks, absorb runoff, and shade the channel. Right Photo: Woody cover typical of Reach 18 conditions. Occasional moderate erosion occurs. Runoff is received from the Winston Plaza mall (left bank) and residential areas (right bank).

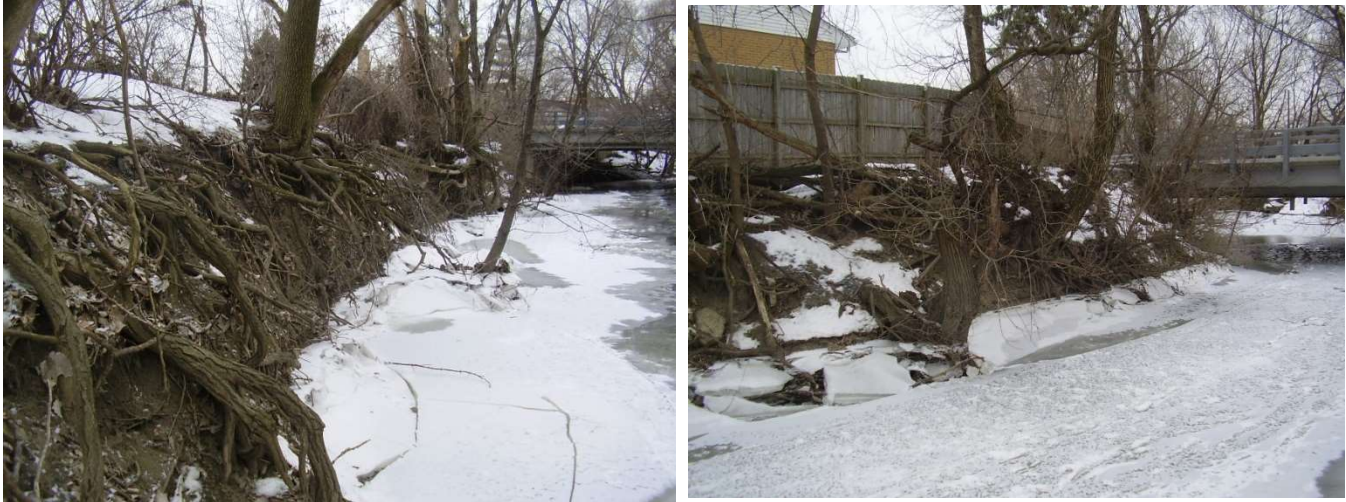
Photos 58 and 59: Streambank erosion is severe downstream of the 9th Avenue Bridge.

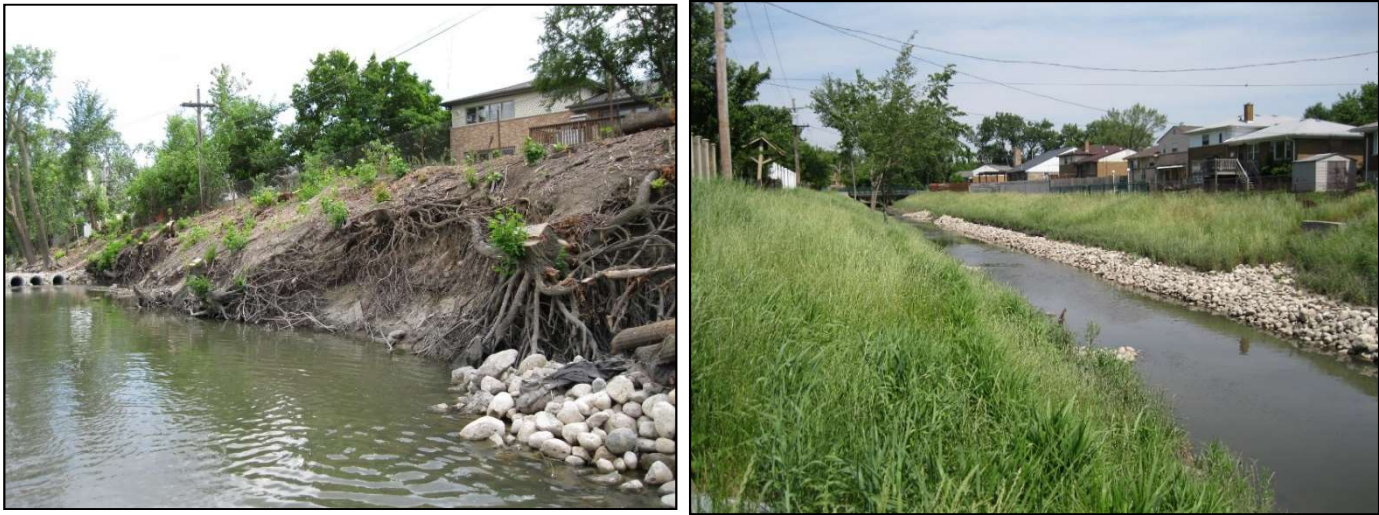
Photos 60 and 61: Before and After Photos of the Phase 3 Silver Creek Stabilization Project completed in 2010 by the Village of Melrose Park near Elsie Drive. Rock toe, re-shaped slopes, rock vortex weirs, rock riffles, and native plantings were installed. Bank stabilization can reduce loadings of pollutants such as total suspended solids, total phosphorus, and/or total nitrogen.

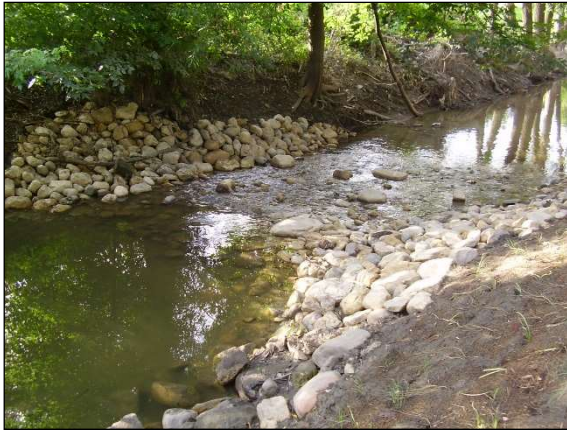
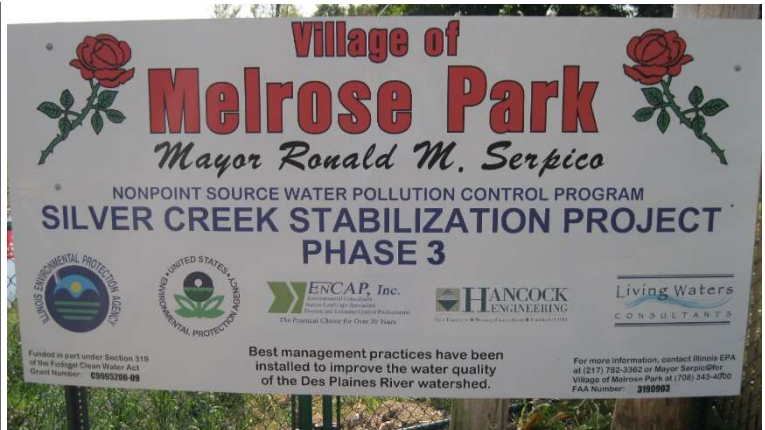
Photos 62 and 63: Dissolved oxygen levels can be improved using instream rock riffle habitat structures to re-aerate the water column. Right Photo: Project Sign for one of the Streambank Stabilization Project Phases informs the public about the Illinois EPA Section 319 Grant Program and the resulting water quality improvement.

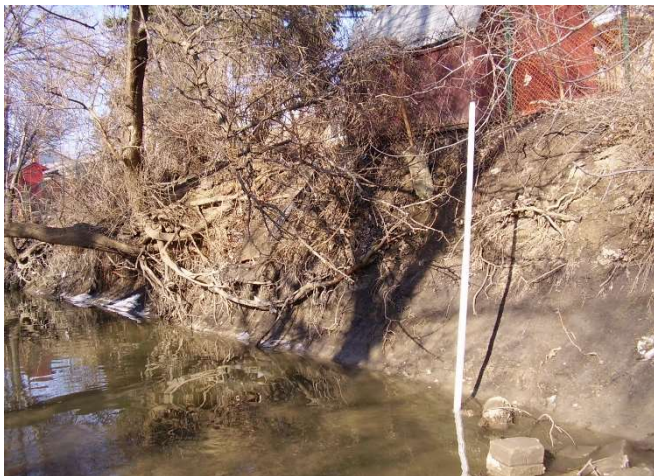
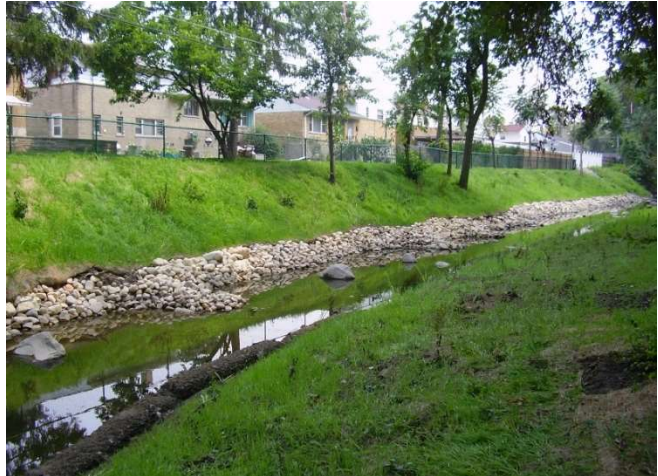
Photos 64 and 65: Before and After Construction of the Phase 2 Silver Creek Stabilization Project completed in 2008 by the Village of Melrose Park, near 5th Avenue. Rock toe, rock points, and re-shaped slopes with native plantings are depicted. Mature willow trees that had been falling into the channel were selectively removed. Native plantings are maintained annually, which is an important ingredient for their establishment and longevity.

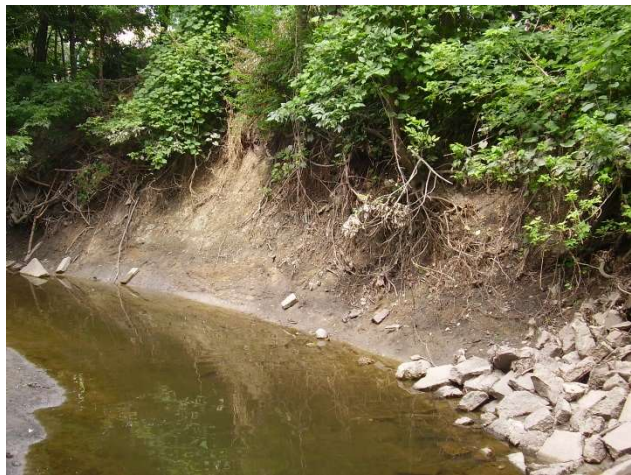
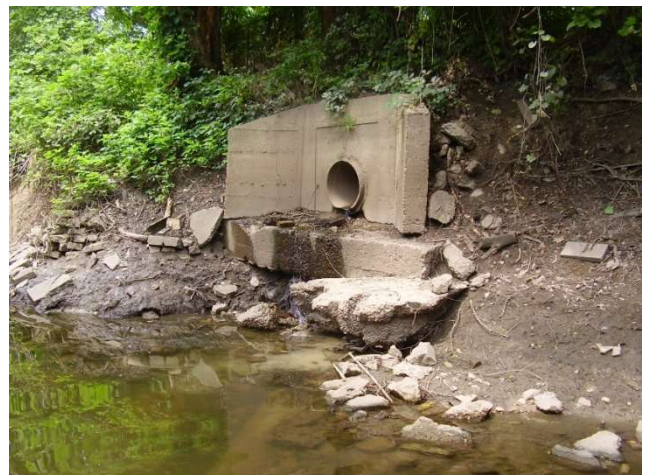
Photos 68 and 69: Severe channel erosion downstream of 5th Avenue. Right Photo: Storm Sewer outfalls deliver runoff directly into Silver Creek, contributing to pollutant loading and scouring.

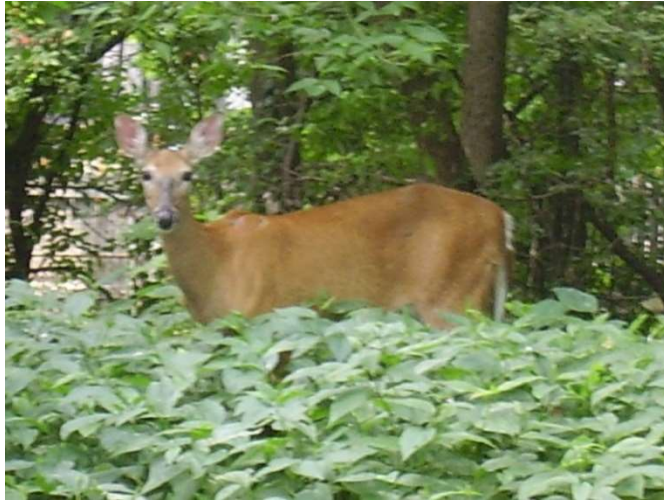
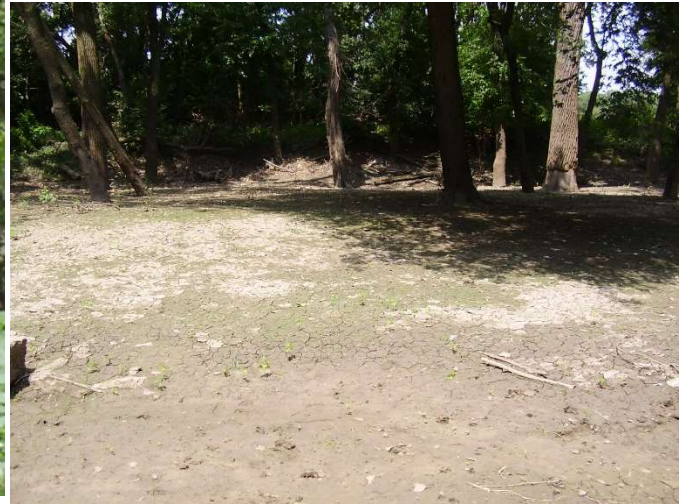
Photos 70 and 71: Deer and other wildlife are frequent visitors to uplands and woodland habitat near 1st Avenue. However, lower floodplain conditions (right photo) could be significantly improved. Silt deposits are commonly observed after overbank flood events. In some cases, vegetative growth is partially impeded, at least temporarily, by the silt accumulations.

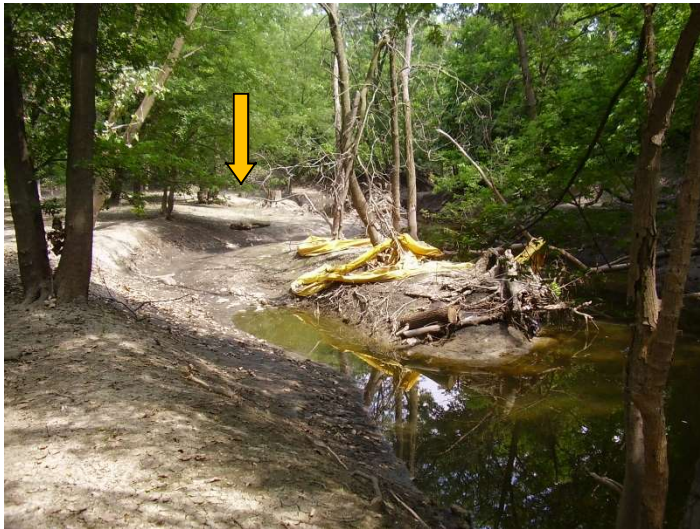
Photo 72: In-stream trees mark past channel bank locations. In some areas, scouring associated in part with debris accumulations has resulted in flows scouring adjacent banks. The resulting sediment loss has since been deposited in the downstream Des Plaines River.

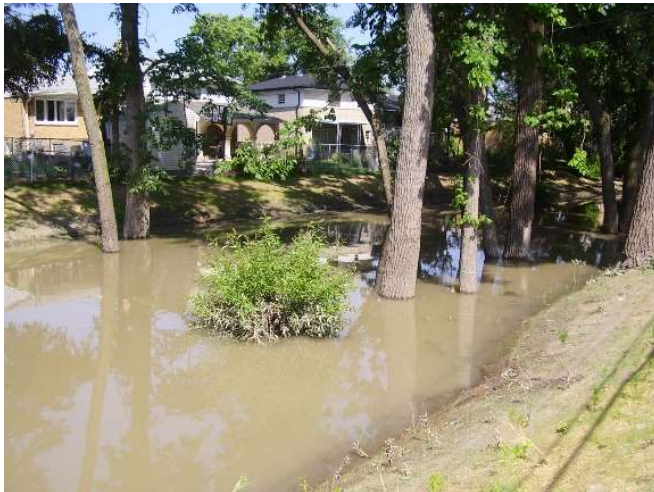
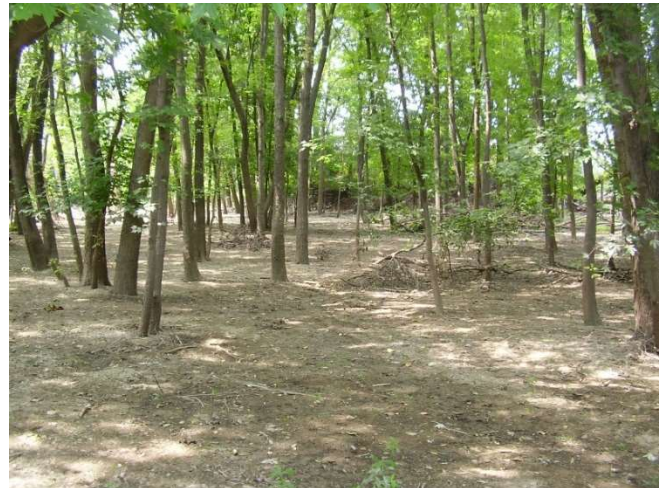
Photos 75 and 76: Example of channel flooding in the downstream area of Silver Creek near 5th Avenue. Overbank flooding has affected residences adjacent to Silver Creek. But relatively tall bank heights (9 ft or more) may prevent further flooding impacts. Right Photo: Example bottomland woodland habitat at the Des Plaines River floodplain near Silver Creek. Water quality impairment along Silver Creek is often impacted by the Des Plaines River conditions due to backwater flooding from the Des Plaines into Silver Creek during major flood events. During spring flooding conditions, the Des Plaines River can be inundated for several weeks at a time.

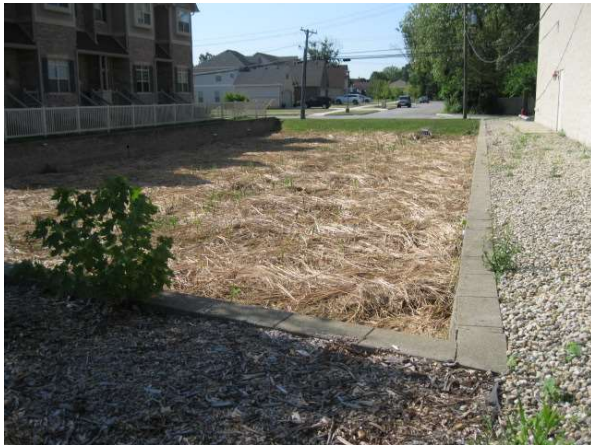
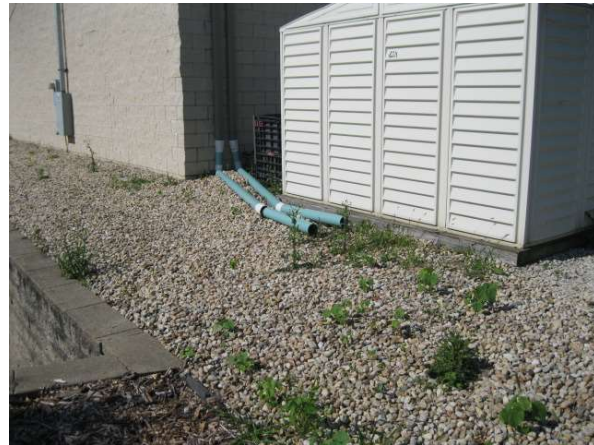
Photos 77 and 78: The detention basin depicted (Basin 1-H) appears to be associated with recent re-development in the upper watershed area. The basin contains mowed cattails. Retaining wall are common, likely in part to maximize runoff storage. The right photo depicts an example of a rooftop downspout that is disconnected from the basin. This allows rooftop runoff to filter and/or infiltrate through the gravel media provide before discharging into the basin.

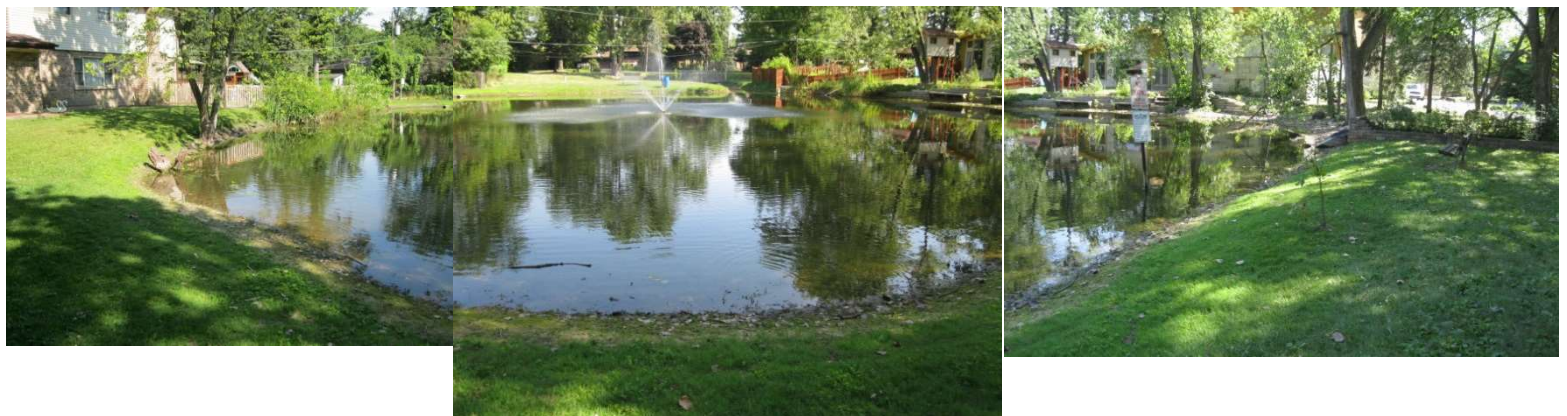
Photos 79 and 80: Lake Mini Ha-Ha is located in a small park in a residential area on the edge of the watershed boundary. Perhaps due in part to limited space available, the shoreline is mowed

turf grass. Converting turf to low-profile native plants would reduce pollutant loading impacts into the lake and downstream waters.

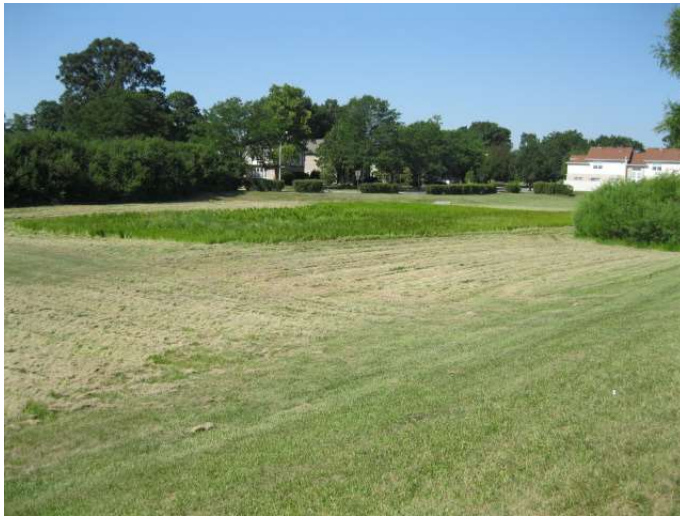
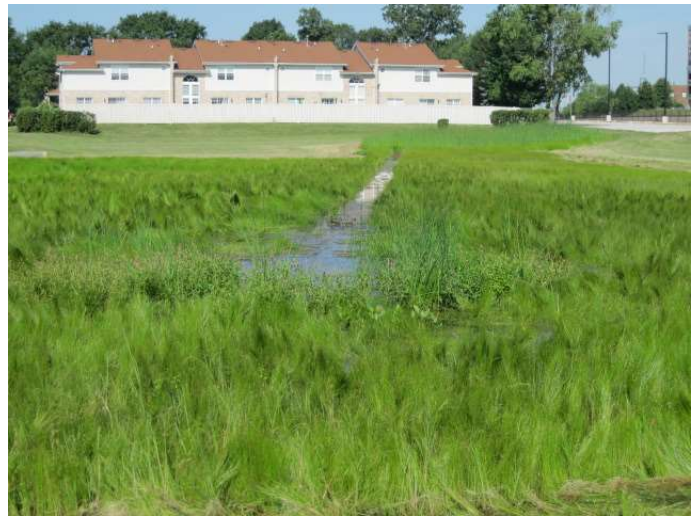
Photos 81 and 82: The far upstream detention area previously described (see also Photos 18 and 19) contains a concentric wetland area surrounded by mowed turf and meadow grasses. In some cases, public education can help to improve the public's acceptability of an aesthetic of taller native grasses in a residential area. Increase wetland and native plant coverage would reduce pollutant loading into the creek from this site, and improve the filtration rate of pollutants from offsite areas.

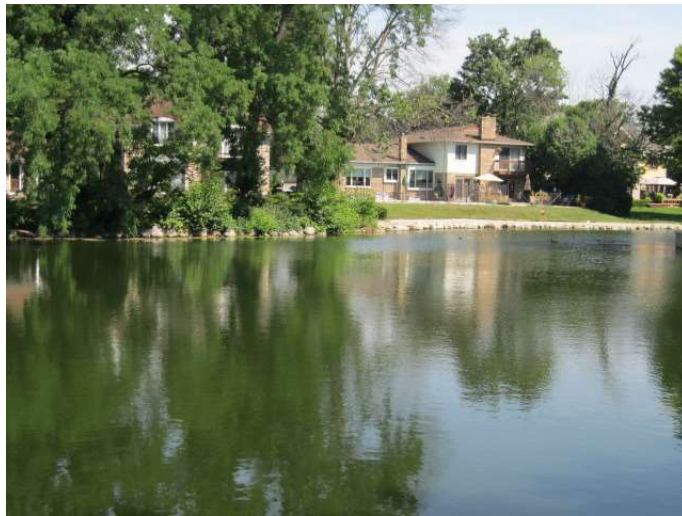
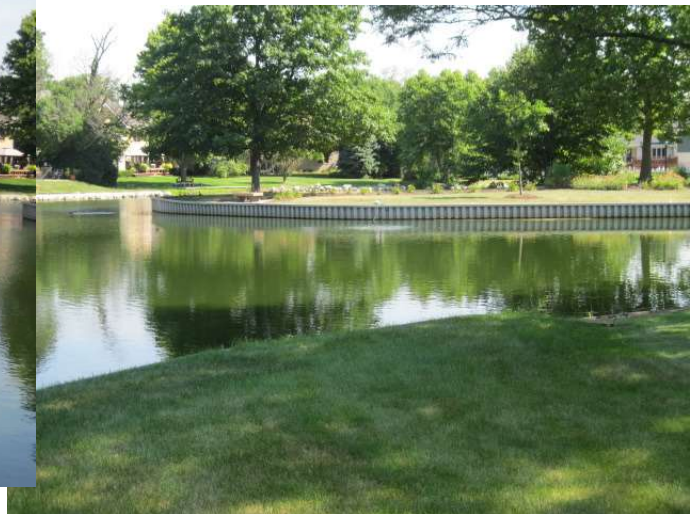
Photos 83 and 84: An unnamed lake (Basin 1-B) with residential areas along the shoreline contains extensive turf grasses at the shoreline with a variety of shoreline stabilization treatments ranging from retaining wall, to rip-rap, to re-shaped turf slopes. It is likely that turf grass pollutant runoff contributed to algae blooms that appear to be present.

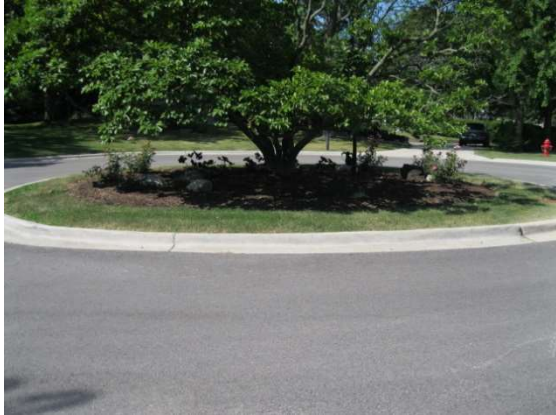
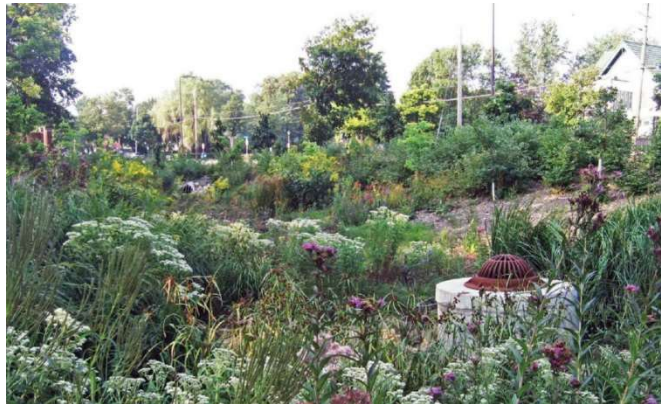
Photos 85 and 86: (left photo): Street cul-de-sac areas contain curb and gutter which efficiently sheds runoff into adjacent lakes. Right Photo: Consideration can be given to convert these areas into depressional storage areas with native plant rain gardens. This can not only provide a site amenity but would improve water quality in adjacent areas (University Minnesota, St. Anthony Falls Laboratory).

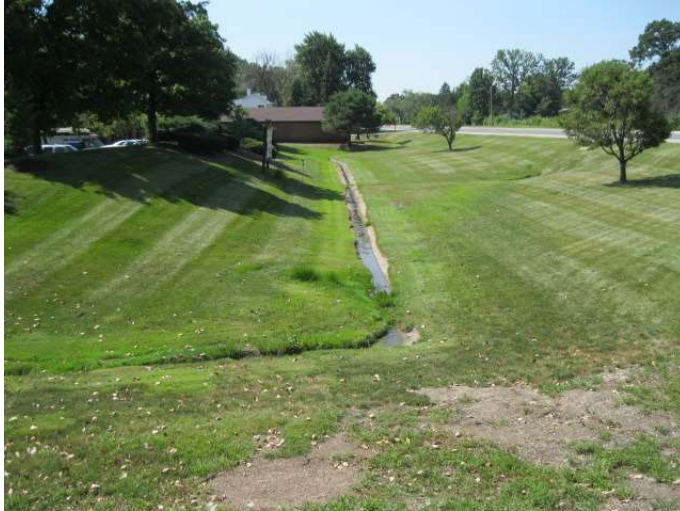
Photo 88: This mowed turf detention area (Basin 2.A) in a multi-family residential development has a low-flow concrete channel in the bottom of the basin. Impervious surfaces such as concrete increase the rate and velocity of discharge of runoff from the basin, and prevents the infiltration of runoff into the ground. This site receives some runoff from Rt. 83 during flood events.

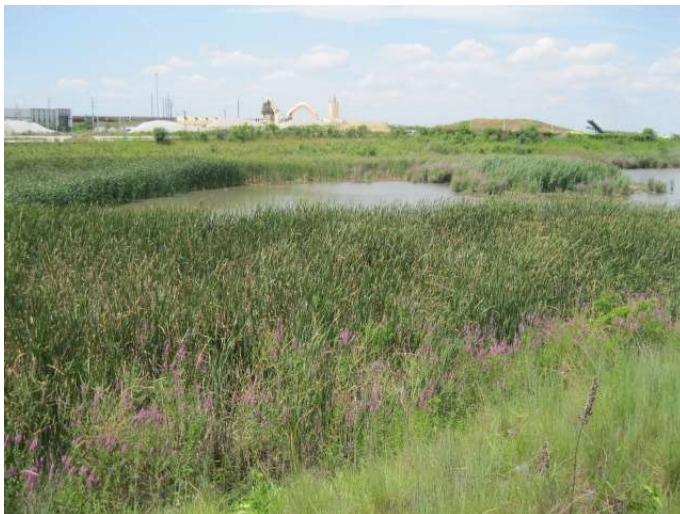
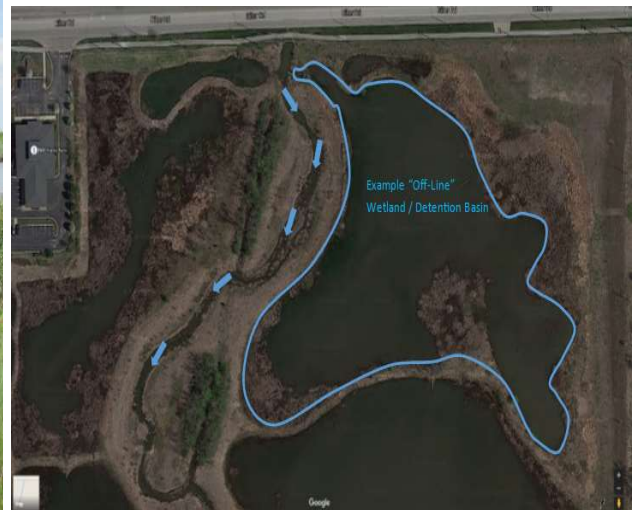
Photos 89 and 90: The O'Hare Airport (left photo) online detention areas previously described (see also Photos 16 and 17) has emergent wetland shoreline vegetation. This along with the open water area provides areas for settling and removal of nutrients and solids from upstream areas. On the negative side, online basins directly on the creek can reduce dissolved oxygen levels and increase water temperatures in the creek. Right Photo: A separate meandering "off-line" creek channel separate from a runoff storage basin during normal baseflow conditions can be constructed to improve water quality. During flood events, the creek overflows into the storage basin for a comprehensive BMP (Source: Living Waters Consultants, Inc.)

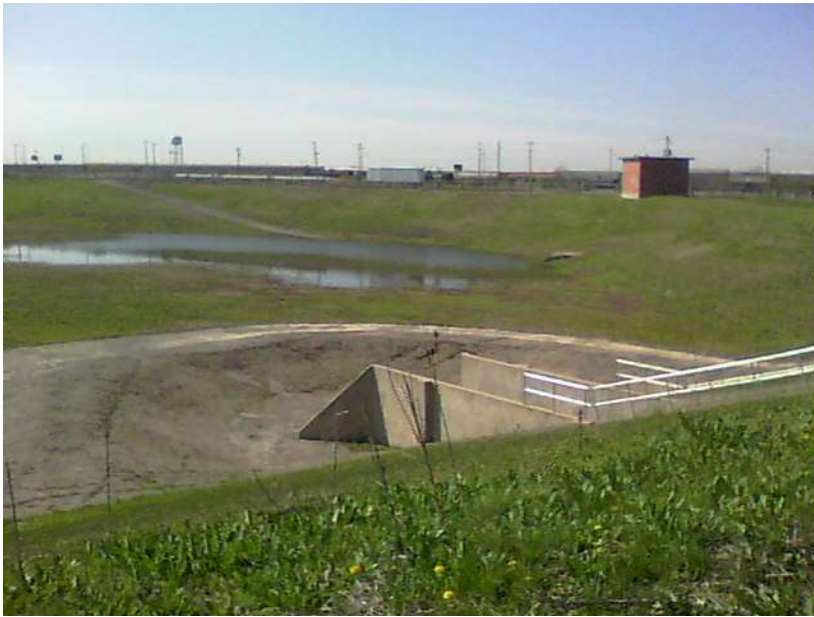
Photos 91 (above) and 92 (below): The largest and most expansive basin in the watershed is the MWRD Basin (a pumped storage facility). This storage area (Basin 7.A.) covers 36 acres of area and is capable of storing 501 acre-feet of runoff. However, Silver Creek is piped through this area. Therefore, the frequency of water quality improvement is extremely rare, and currently limited only to large-scale flood events. It would be desirable to not only install native plantings on the side slopes to improve runoff storage and infiltration and possibly lower maintenance costs, but also to evaluate alternatives to divert stream flows through the lower basin area as a more consistent water quality improvement technique.

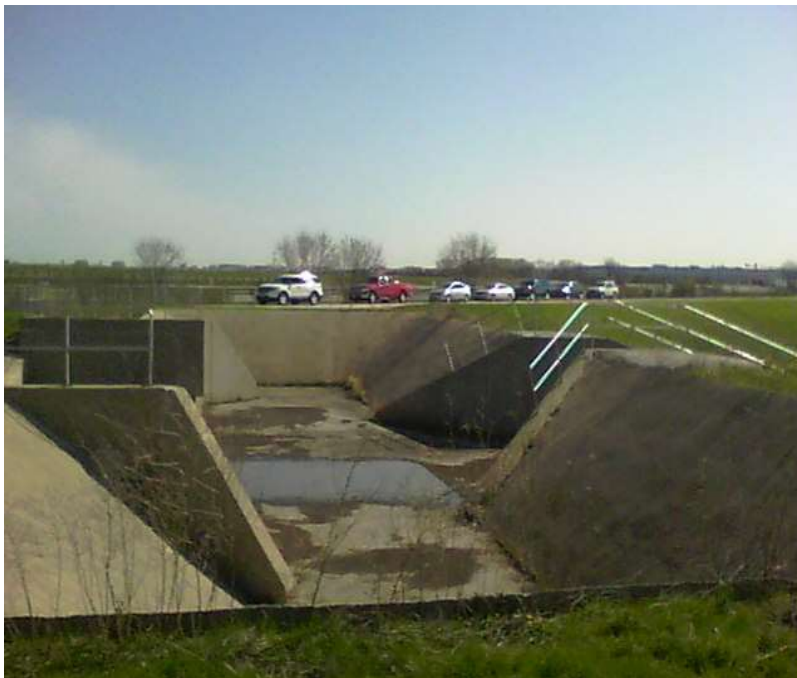
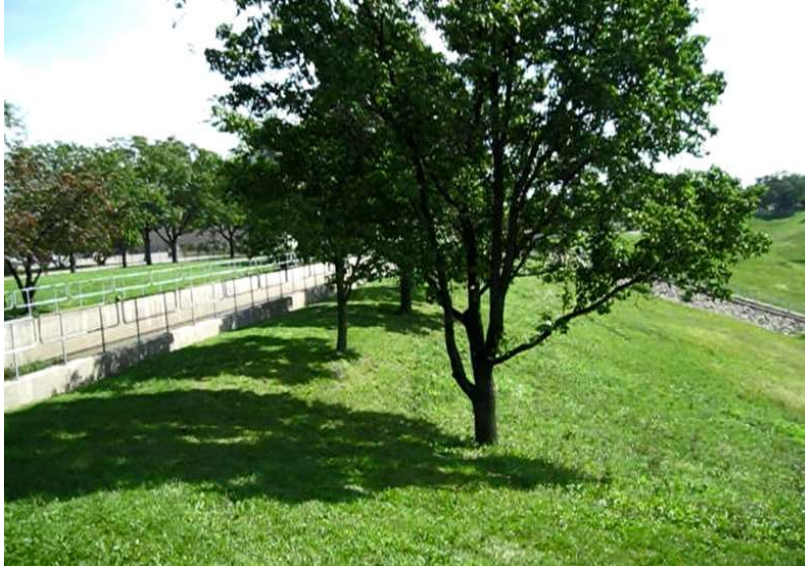
Photo 93: The 50 acre-foot volume Jack B. Williams reservoir in Franklin Park. The concrete-lined Silver Creek channel (at left) completely bypasses the reservoir except during flood flows.

S-21	12.2	Detention Retrofit Recommendation: Route Baseflow from Silver Creek Through Jack B. Williams Reservoir Basin Bottom With Frequent Pumpout for Water Quality and Aquatic Habitat Improvement. Excavate Bottom of Reservoir Slightly (Depth to be Determined Through Engineering Study) So That Baseflow Elevations Resulting from Flow Routing Do Not Reduce Existing Flood Storage Volume.	8.7	AC	Village of Franklin Park.	TBD	TBD	1,055	16,717	2,128	A
S-22	12.2	Naturalized Runoff Storage Recommendation: Convert 0.5 Acres of Parking Lot Area West of Riverside Street into Expanded Creek Corridor. Convert Concrete Channel Into Re-Graded Side Slopes With Native Plantings. Install Bioswale(s) In Current Parking Lot to Reduce Runoff Into Silver Creek.	882	LF	To Be Determined (TBD).	\$315,000	\$4,000	28	99	31	A
S-23	13	Stream Enhancement Recommendation: Convert Concrete Revetment Mat Side Slopes and Velocity Dissipators Channel Into Re-Graded Side Slopes With Rock Toe, Re-Shaped Slopes, and Native Plantings. Install Rock Riffle Structures as Energy Dissipators. From Scott Street to Fullerton Avenue.	5,004	LF	To Be Determined (TBD).	\$640,000	\$6,000	149	298	149	B

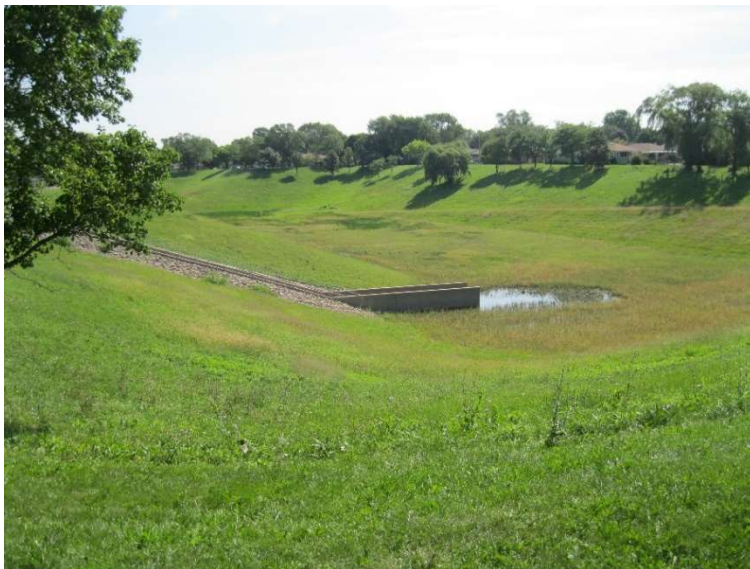
Photo 94: Water levels in the reservoir are pumped out to provide flood storage capacity. This basin could be modified to improve water quality by installing native plant side slopes. (Note: Some communities such as Franklin Park have ordinance restrictions on plant heights.) Other improvements could include constructing a wet detention basin, a meandering low-flow creek corridor, and/or wetland habitat within the basin. Unfortunately, at present Silver Creek flows are not routed through this basin, except during flood flows. Therefore, no consistent water quality improvement occurs at this time. This is significant in part because the Silver Creek corridor adjacent includes some of the most degraded reaches in the entire watershed (See Photos 35 through 39).

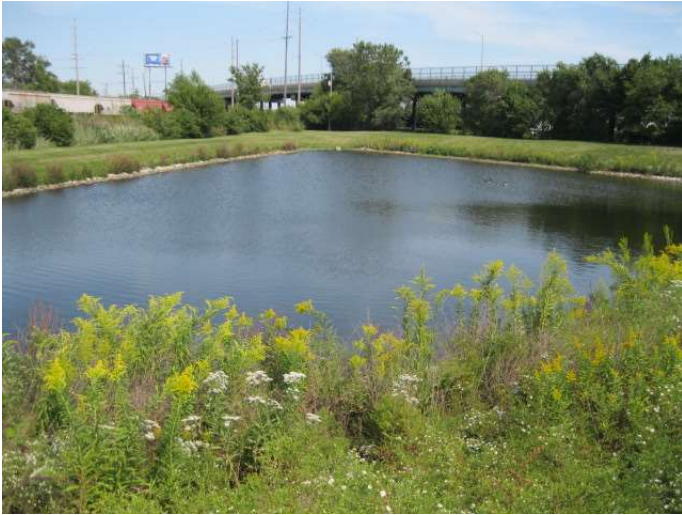
Photo 95: Industrial detention areas vary widely in condition. Some have no shoreline vegetation. Some are located immediately adjacent to large parking lots or other paved surfaces. Basin # 16.A. depicted contains a mixture of mowed turf grass and taller native plantings (foreground).

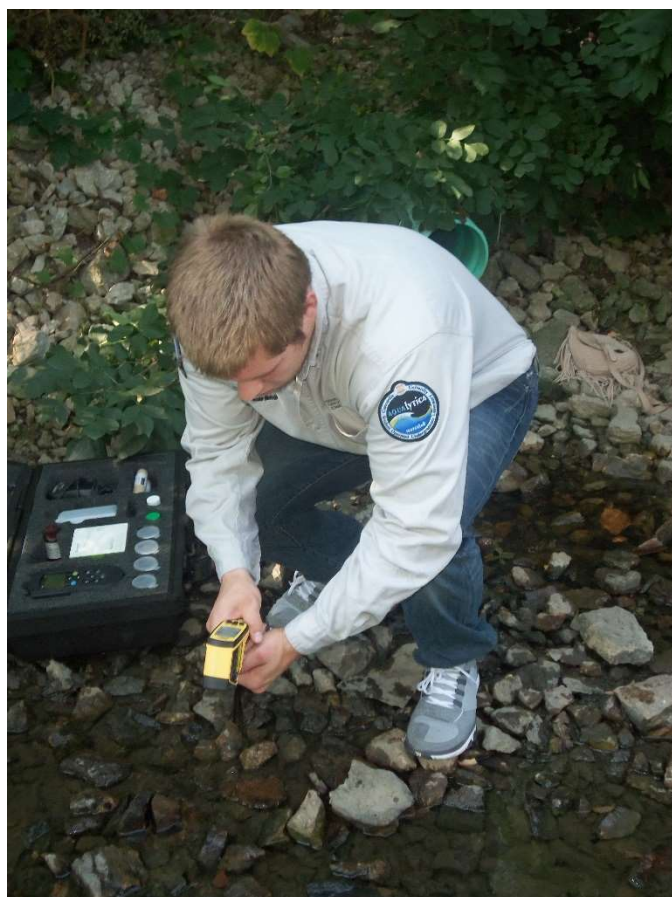
Photo 98: Concordia University students and professors have been collecting water quality samples from Silver Creek since 2013.

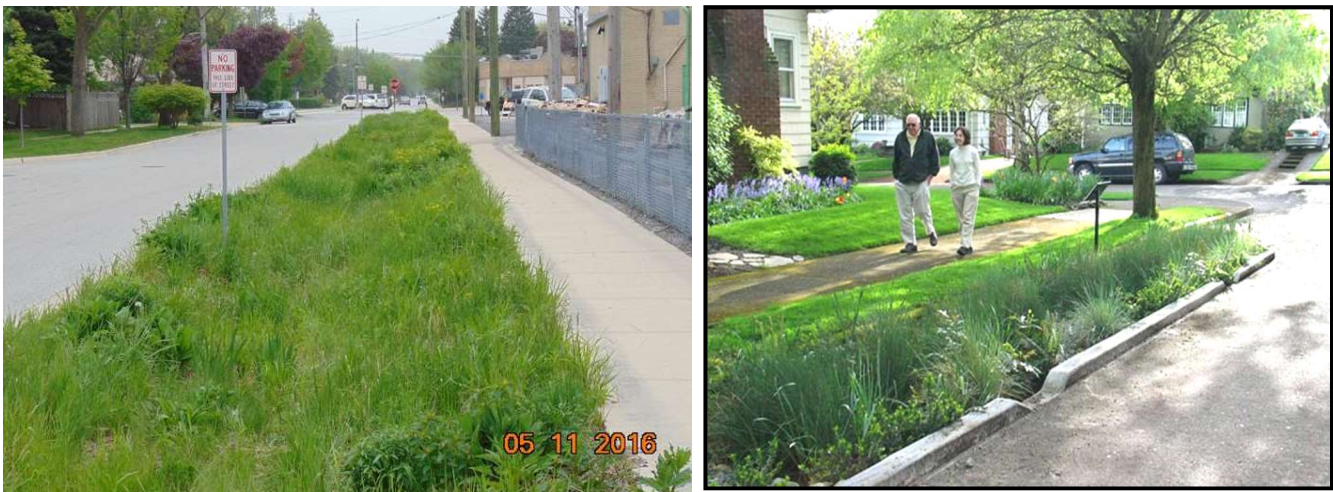
Photos 100 and 101: Urban bioswales can be retrofitted along street rights-of-way to significantly reduce runoff volumes and associated pollutant loading. Signage can help to educate the public.

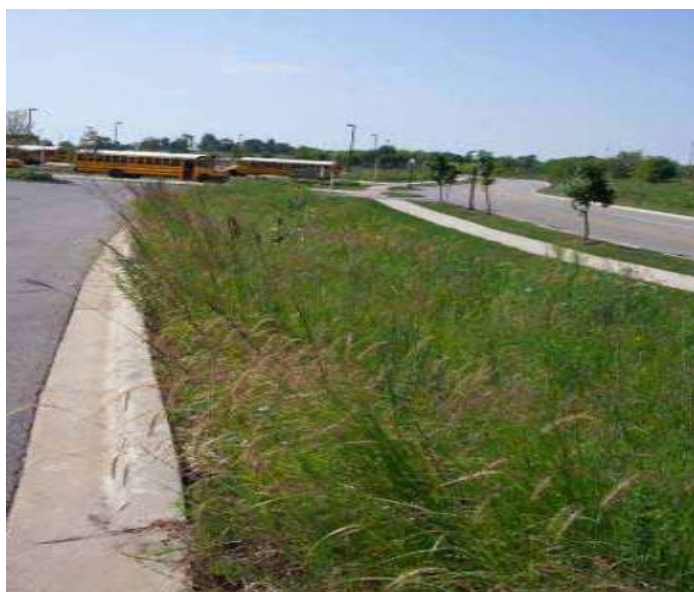
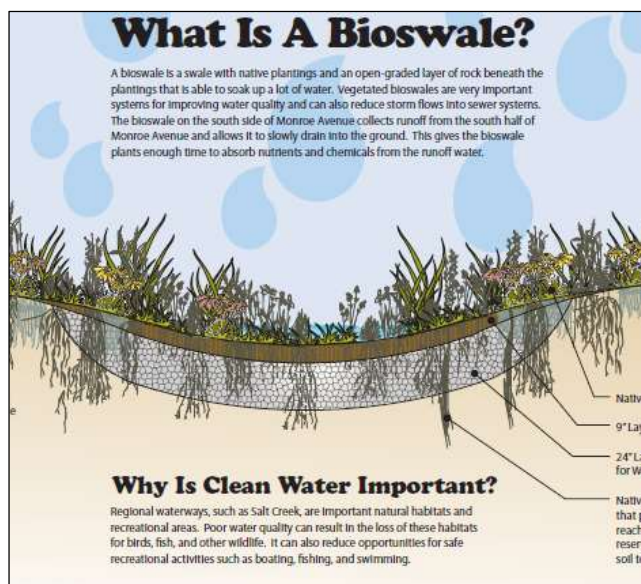
Photo 102 and Exhibit 9: In contrast to bermed parking lot islands with which rapidly shed runoff, depressional bioswales with (depicted) with aggregate areas below-ground can absorb and filter runoff. Native plants can help improve runoff absorption.

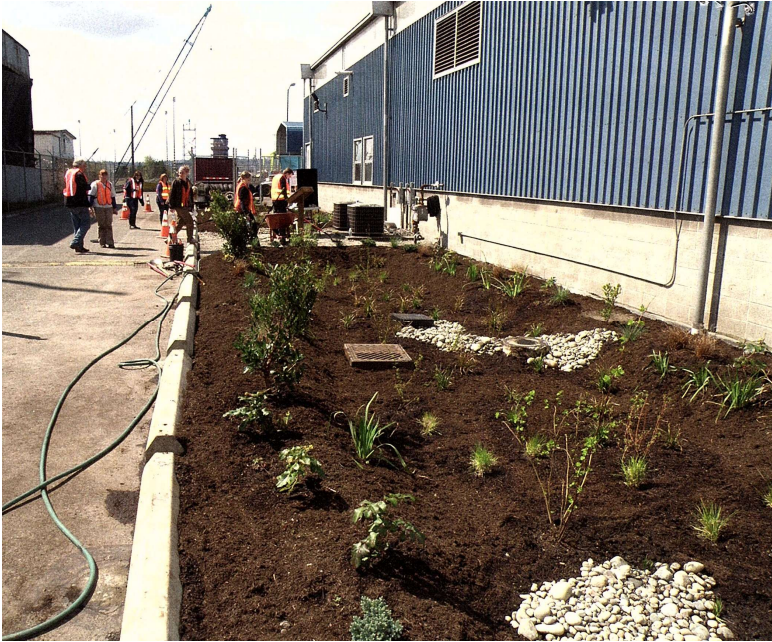
Photo 103: Rain gardens can be expanded for industrial and commercial areas. They can be constructed within and adjacent to impervious surfaces such as parking lots. In some cases, rain gardens can store and treat up to 10% of the parking lot runoff.

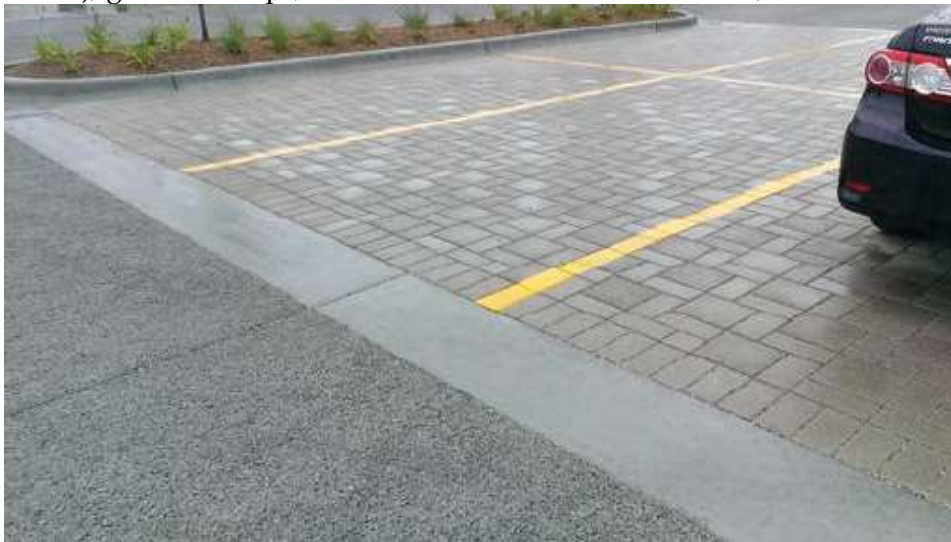
Photo 104: Example permeable pavers (right) and porous concrete (left) in a parking lot to infiltrate large volumes of stormwater runoff prior to discharge (Photo Courtesy Village of Franklin Park at the Police Station).

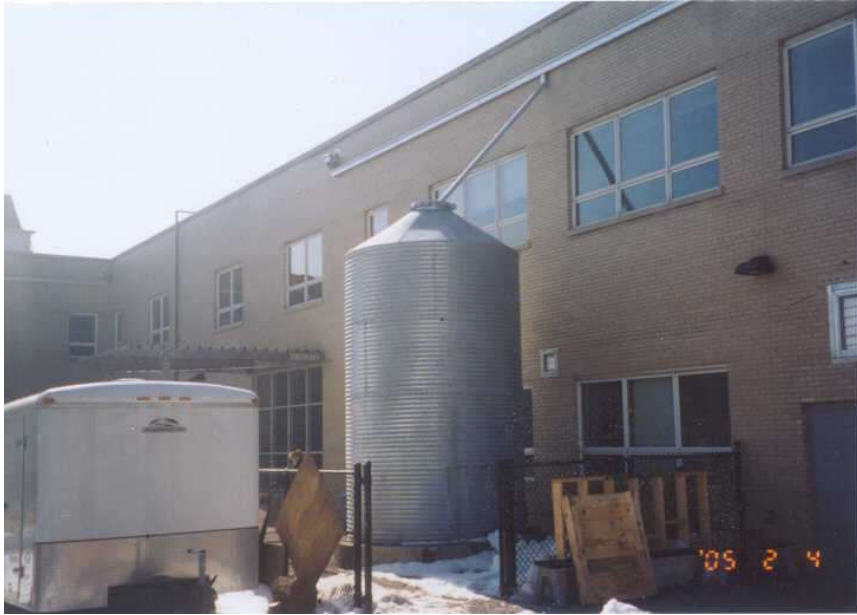
Photo 105: Office building equipped with a large cistern to collect rooftop runoff. Cisterns can be fitted with hoses, or integrated with landscape sprinklers to water the property's landscaping instead of using drinking water. If implemented extensively, cisterns can reduce runoff, pollutant loading, and nuisance flooding in developed areas.

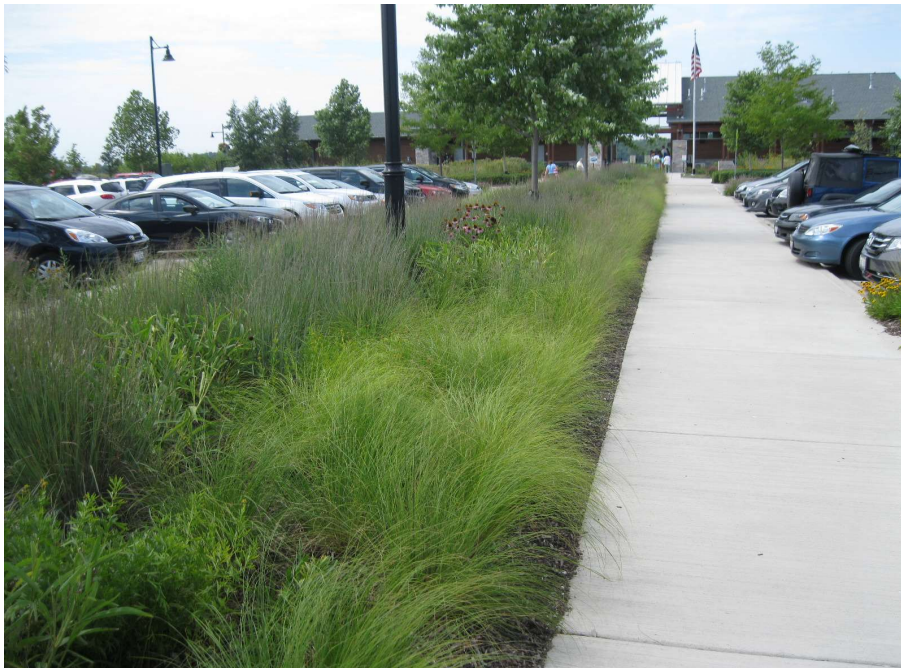
Photo 106: Installation of a linear bioswale with native plants in a setting with expansive parking lots.
