SILVER CREEK WATERSHED-BASED PLAN

Illinois EPA Section 319 Financial Assistance Agreement 3191402

Illinois Environmental Protection Agency
Bureau of Water
Watershed Management Section
July 2016

**SILVER CREEK WATERSHED-BASED PLAN
RESOURCE INVENTORY**

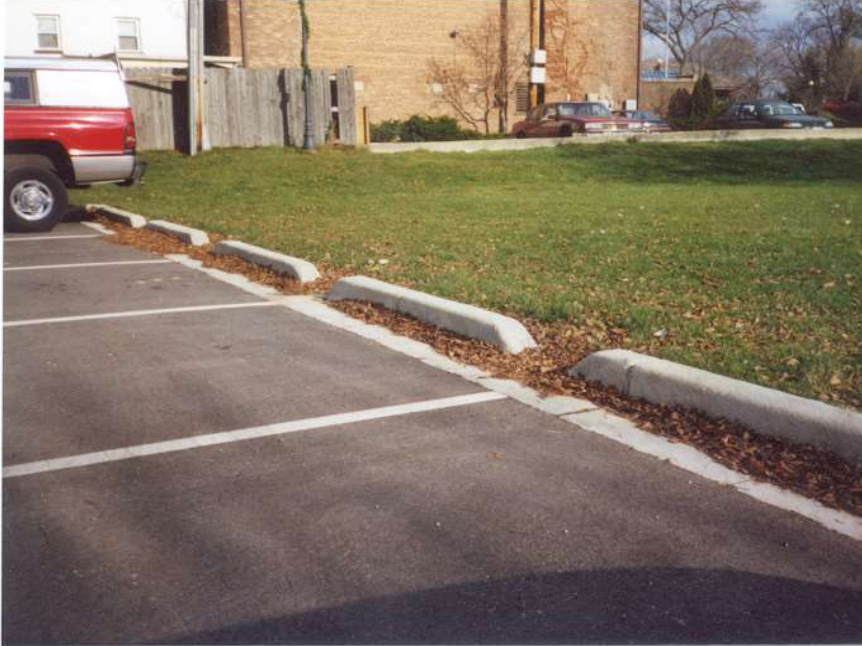
Photo 107: Curb cuts can direct runoff into adjacent vegetative grass filtration areas, rather than collecting 100% of the runoff into the storm sewer system. Treating runoff at the source includes directing it to infiltration areas to the extent practicable. Once runoff enters the storm drain system, all pollutants are then efficiently conveyed into Silver Creek.

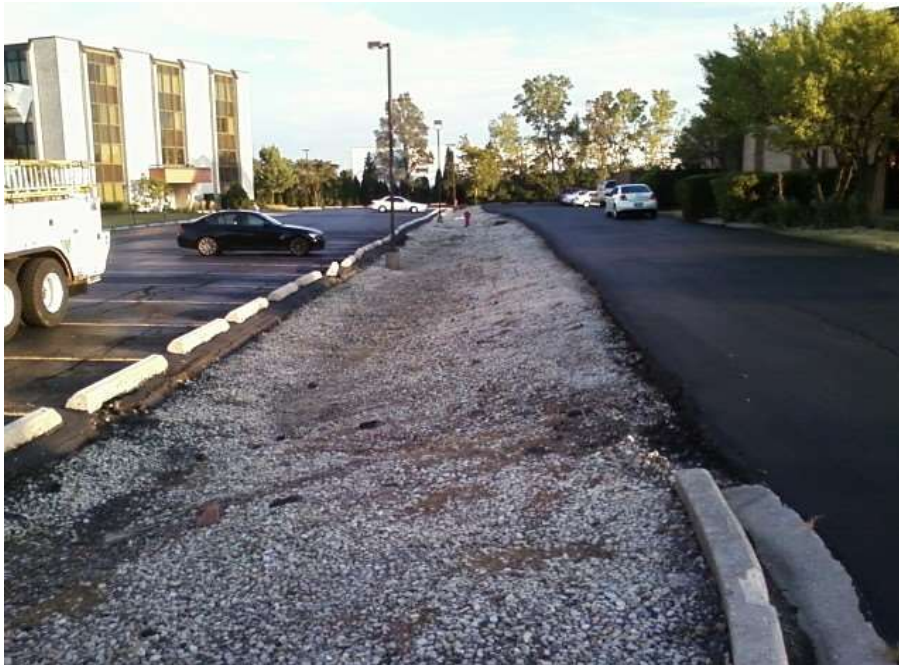
Photo 108: While vegetated areas are preferred, even low-maintenance gravel areas can be used to infiltrate runoff into soils before the pollutants are discharged into the sewer system.

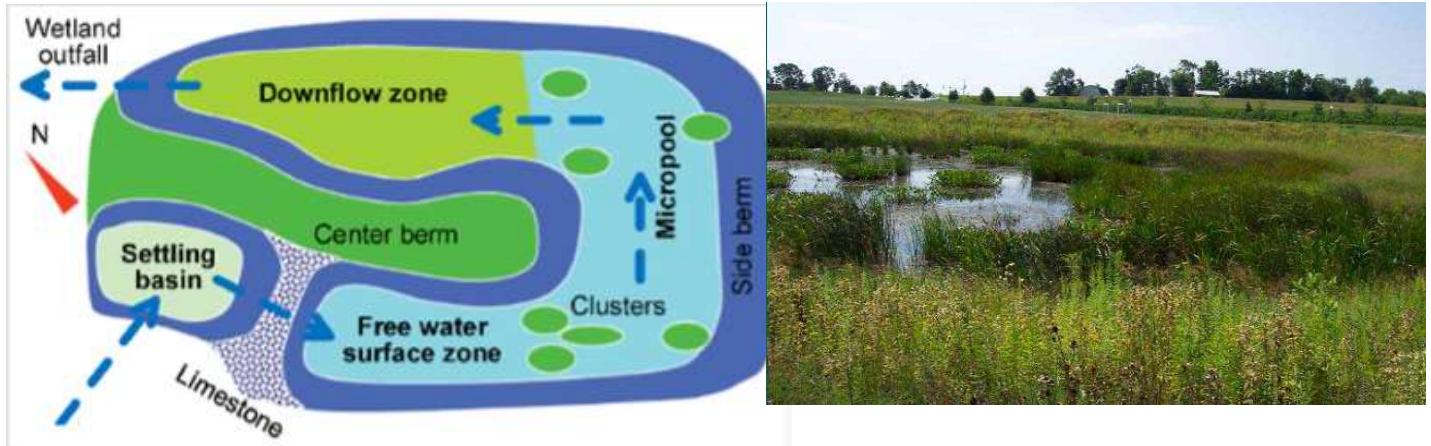
Exhibit 10 and Photo 109: Example wetland filtration basin. Note maximum flow path through wetland area to improve water quality (Source: Watershed Management 2000 Conference, Water Environment Federation).

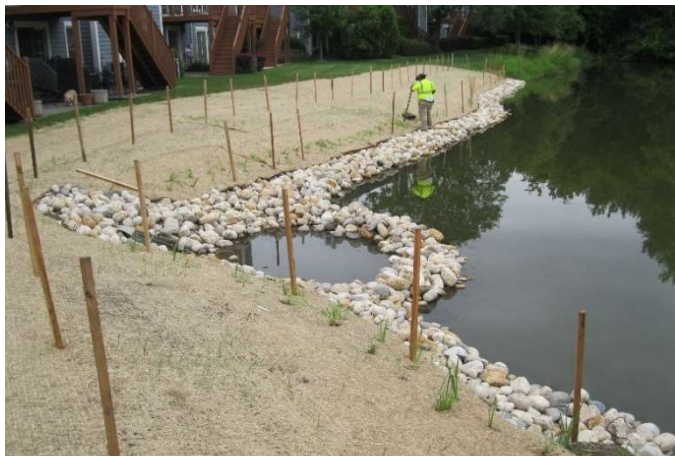
Photo 110: Storm sewer inlets into ponds or detention basins can be modified by constructing sediment forebays (typically the larger the better). Sediment forebays can contain runoff and settle suspended solids before they are carried into the pond area.

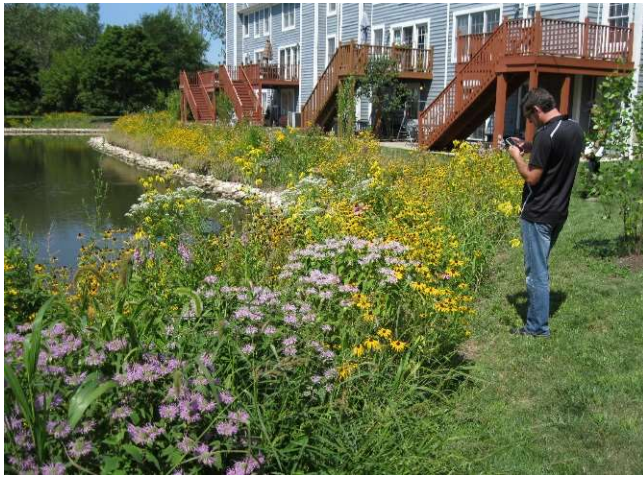
Photo 111: Conversion of turf grasses into native plantings directly reduces nutrient loading into ponds, basins, and downstream Silver Creek.

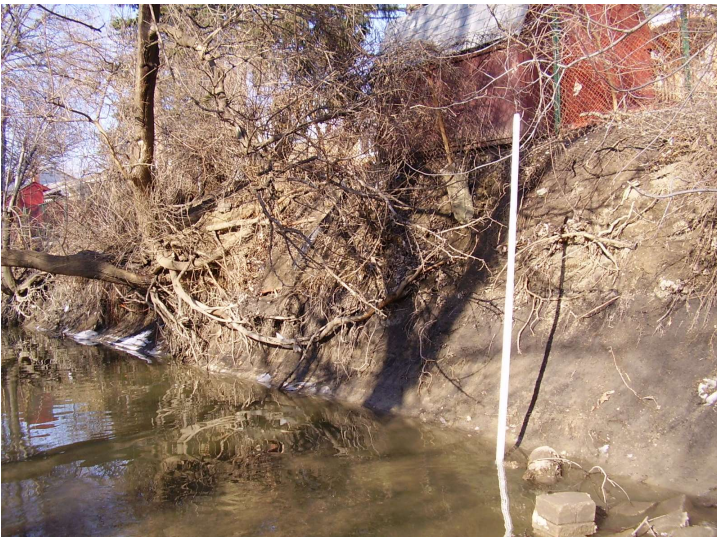
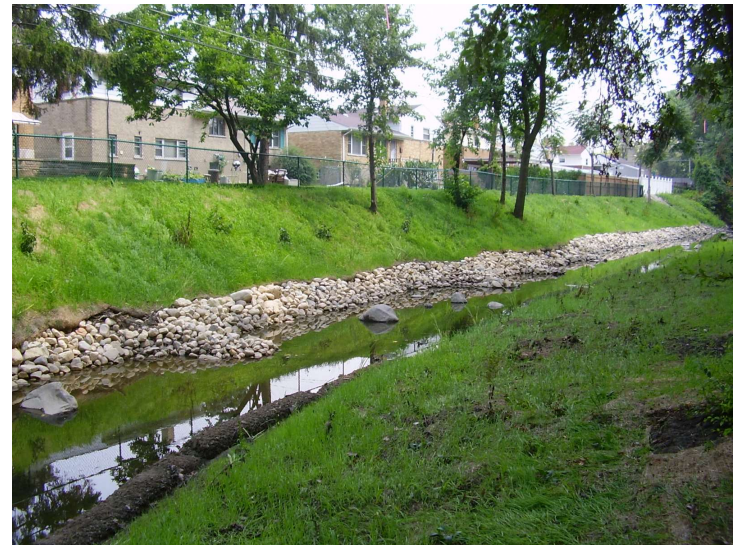
Photos 112 and 113: Before (left) and after (right) example of streambank stabilization on Silver Creek in a residential setting with limited access for construction. BMPs installed by the Village of Melrose Park include re-shaped slopes, vegetation management, rock toe, rock points, boulder energy dissipators (riffles (not pictures), wetland enhancement, and other measures.

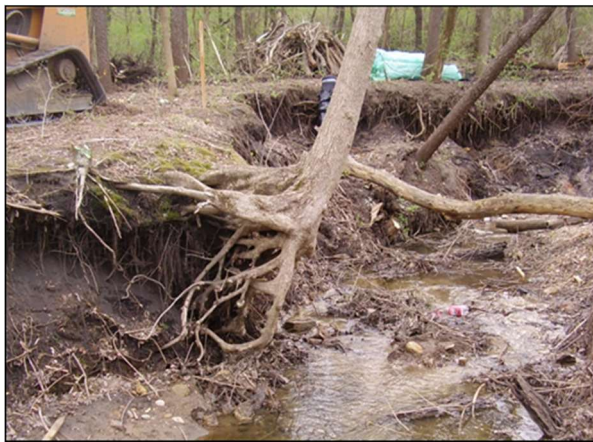
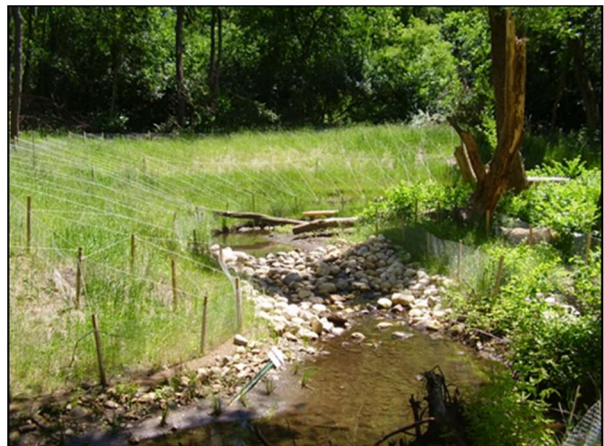
Photos 114 and 115: Example before and after conditions illustrate the implementation of stabilization and restoration practices such as rock riffle structures, rock toe, tree rootballs, vegetated geogrid lifts along the bank, and native plantings to implement stream stabilization.

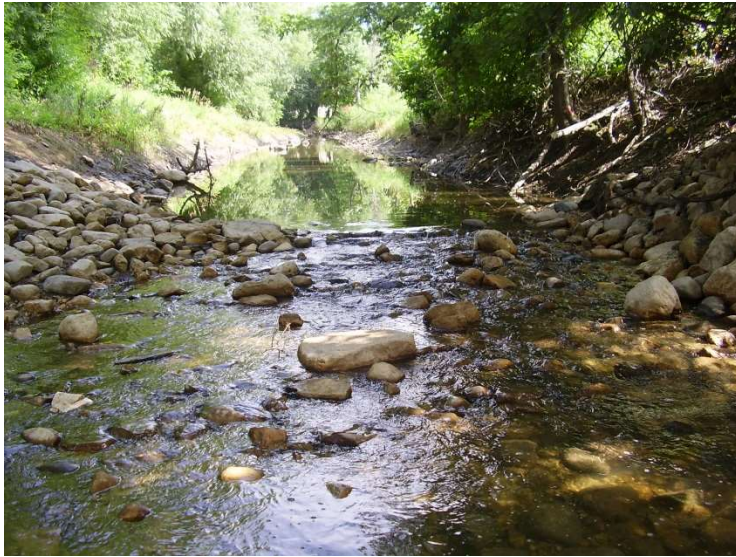
Photo 116: Riffle structures can be installed on Silver Creek to re-oxygenate the water column. This riffle structure on Silver Creek is located approximately 0.5 miles upstream of 5th Avenue. Riffles also dissipate flow energy, and provide increased habitat diversity.

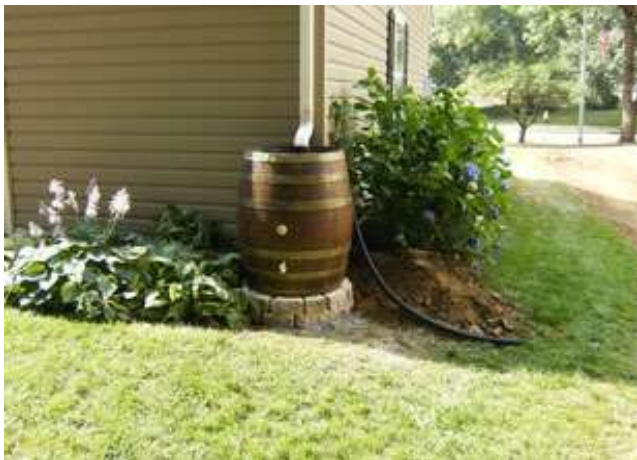
Photo 117: Residential areas can be equipped with rain barrels to reduce runoff volume.

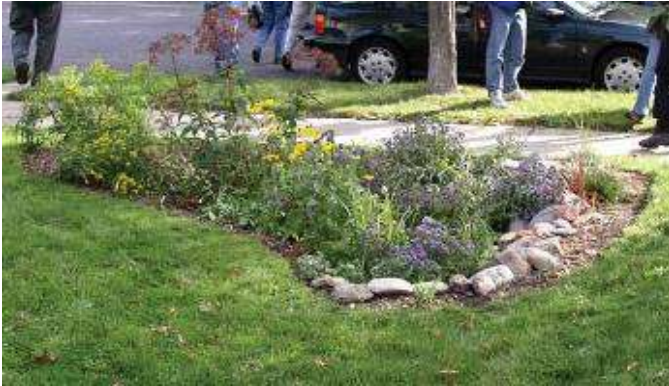
Photo 118: Residential areas can also contain rain gardens to filter runoff before discharging into storm sewer systems at the streetside area.

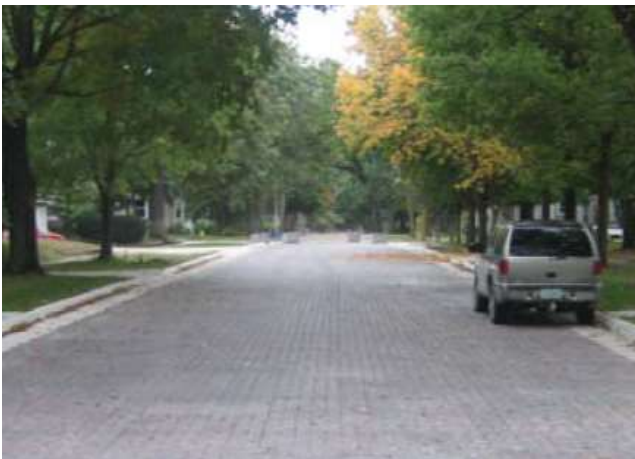
Permeable paving materials include interlocking concrete (or clay) unit pavers, porous concrete, or porous asphalt. These systems allow rainwater to flow through the paving surface into underlying layers of gravel and soil. The water moves very slowly through the underground layers where it is cleansed, slowly evaporated, and released to deeper soil layers or storm sewers. These systems reduce stormwater runoff, reducing ponding in the neighborhood and flooding downstream and improving water quality. In comparison to a traditional system, the quantity of water that drains to the storm sewers from permeable pavement is significantly reduced and the quality is improved.

Photo 119: Green streets installed with permeable pavers can reduce runoff volumes by 50% or higher during large rainfall events. Pavers may reduce the need for road salt applications since less ponding will occur. (Source: CDF, Inc. Charles City, Iowa public brochure.)

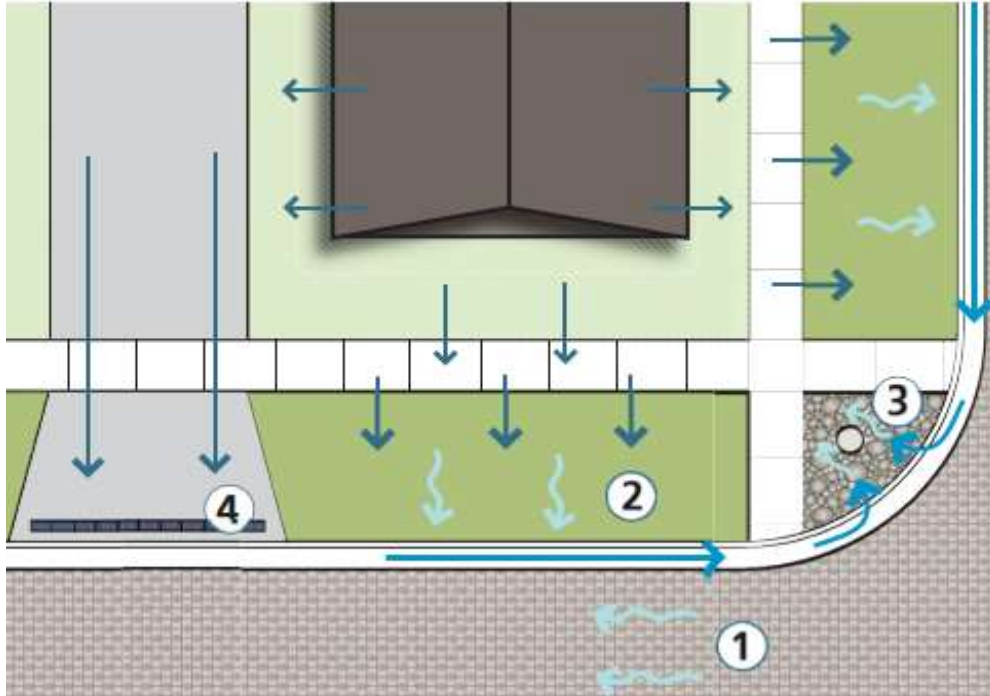
Fig. 32: Residential areas can be converted into environmentally sound stormwater management areas using (1) porous paving, (2) amended soil infiltration areas, (3) cobble infiltration areas, and (4) trench drain infiltration areas. Examples are provided below. (Source: CDF, Inc. Charles City, Iowa public brochure.)

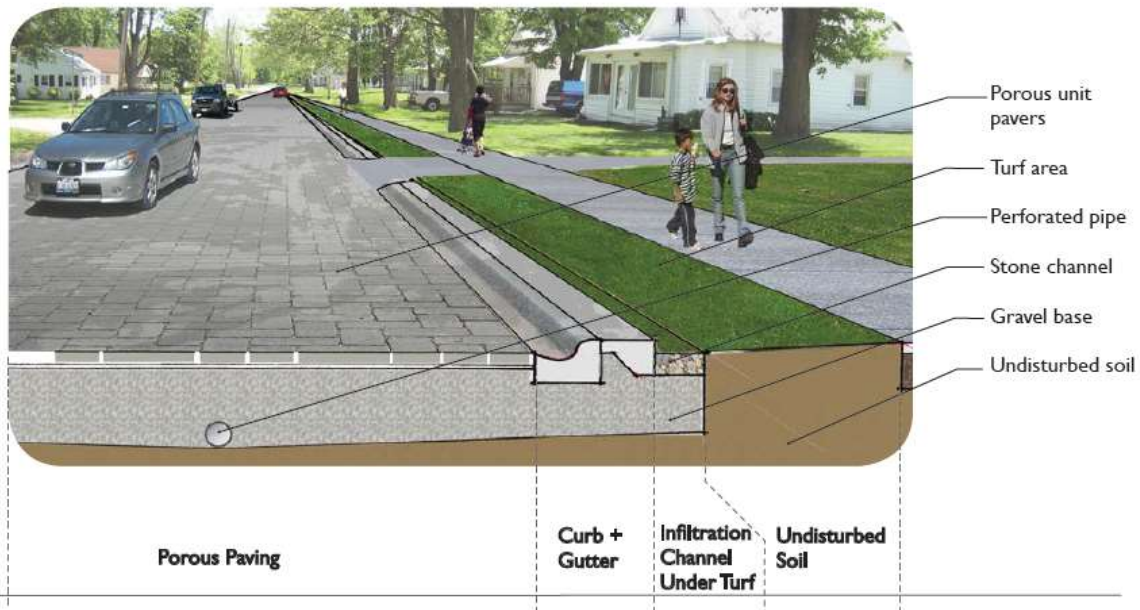
Fig. 33: Cross section of potential residential street BMPs including porous paving with aggregate base layer, stone channels with infiltration alongside curbs, and amended soils.

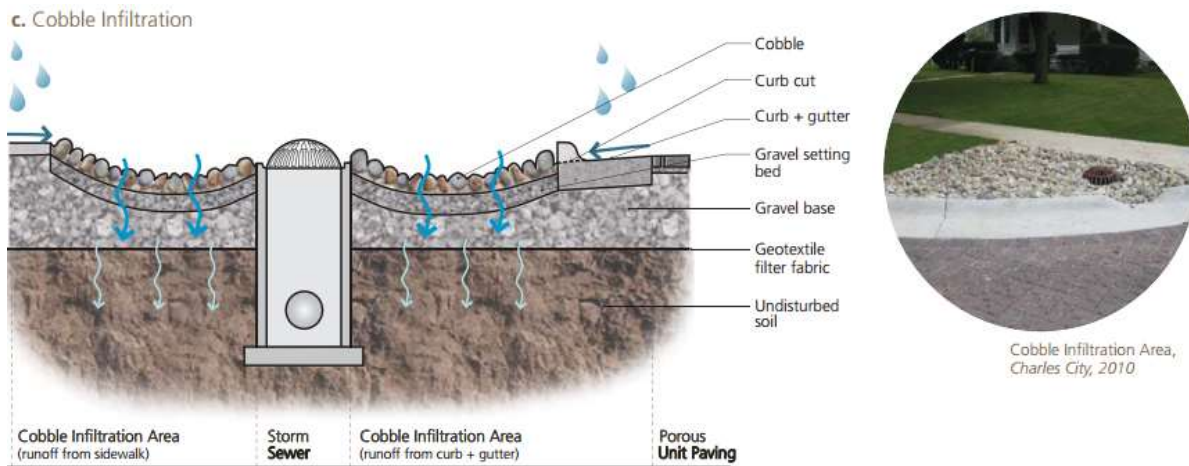
Fig. 34: Residential corners can be retrofitted with paver-lined or rock-lined infiltration areas. These depressional infiltration areas can reduce runoff volumes and improve water quality.

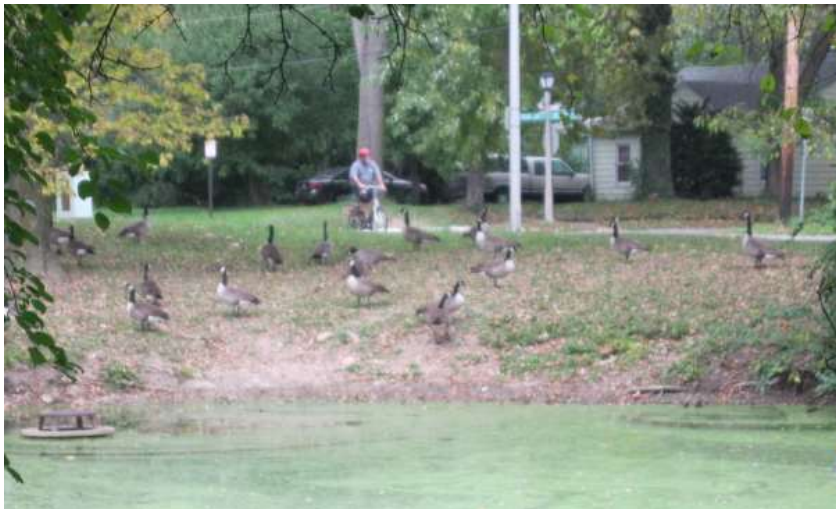
Photo 119: Turf grass along shorelines and parks can serve to attract Canada geese. Geese prefer turf grass for feeding. They may also prefer turf because it gives them a sense of protection from predators. Turf grass also lacks the capacity to stabilize shoreline soils. Due to a lack of root structure and infiltration capacity, runoff from turf can contribute to nuisance weed growth within a basin.

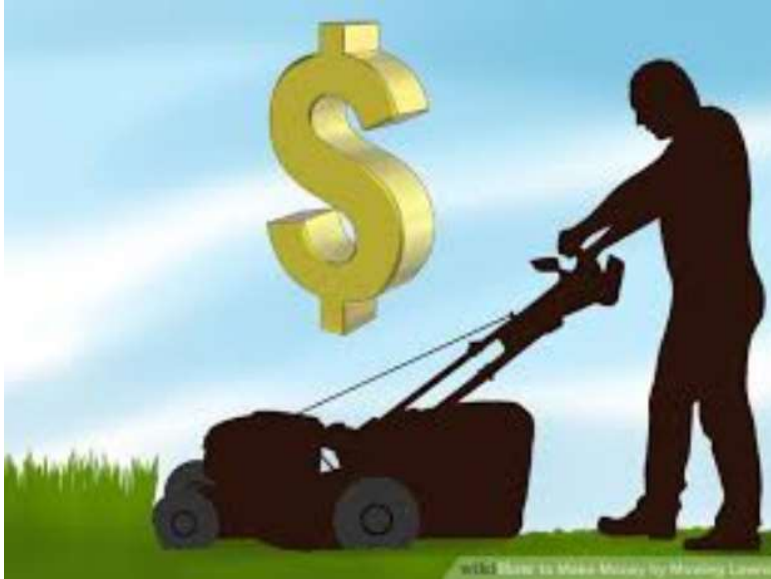
Exhibit 12: Mowing costs can be high. Not only that, it requires a lot of chemical and watering input to be maintained. Native plants can reduce runoff, reduce maintenance costs, reduce pollutant discharge, and improve water quality. Native plants can also help to deter Canada goose populations.

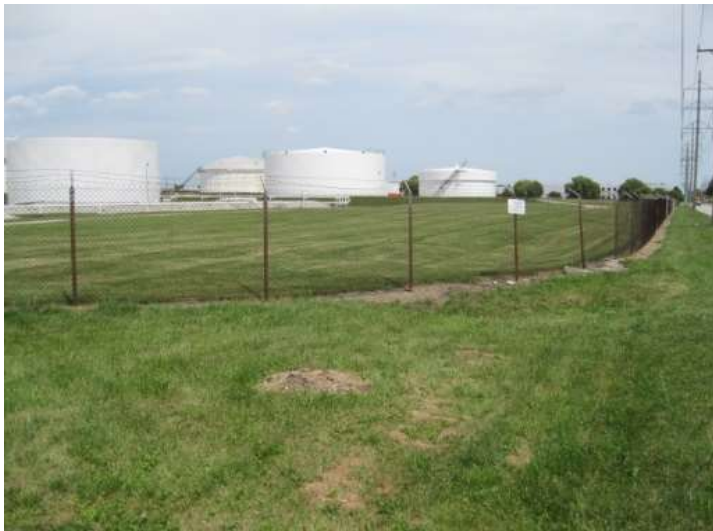
Photo 120: Some large-scale industrial areas in the Silver Creek watershed could in some cases be converted to partial or full native plant coverage. Where implemented, native plantings can reduce maintenance costs, reduce runoff, increase infiltration, and provide more habitat diversity.

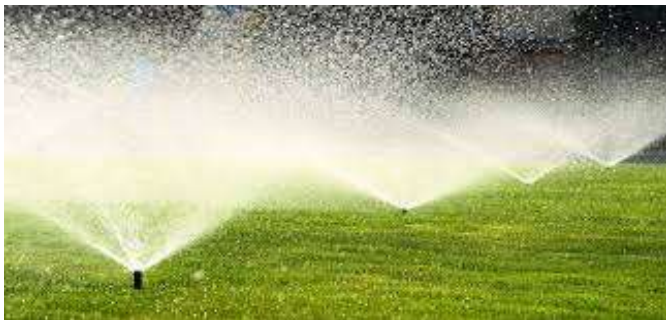
Photo 121: Example wastewater reuse spray irrigation system for turf grass.

Although wastewater discharge is not a dominant source of pollutant loading in Silver Creek, wastewater treatment plant discharge can contribute to water quality degradation. A more innovative approach to wastewater treatment includes wastewater reclamation and reuse (WRRS). In a WRRS system, the treatment time can be up to 36 days. After treatment and disinfection, the reused water can be used to irrigate turf grass, golf course, park lands, and other open space. As a result, the nutrients in the water are recycled into vegetative growth rather than discharged into the receiving stream. Irrigation occurs during the vegetative growing season and it is applied at a slow rate. In the process, discharge of pollutants to the Des Plaines River is reduced. Treated water is stored in a storage reservoir during the non-irrigation (winter) season. WRRS systems can improve water quality for streams, rivers, and other waterways. Wastewater reclamation and reuse systems (WRRS) differ from conventional WWTP in several respects.

Description	Traditional Wastewater Treatment	Wastewater & Reuse Treatment
Duration of Treatment	ca. 1-2 Days	36 Days
Energy Efficiency	Lower	Higher
Effluent Discharge	To Stream Channel	Land Application
Use of Treated Water for Irrigation	None. Pollutants Discharged to Stream.	Irrigation of Turf, Parks, Natural Areas, or Crops in Growing Season
Duration of Winter Storage of Treated Water	0 Days	150 Days
Sludge Generation	High	Low
Sludge Hauling Costs/ Land Application of Sludge	High	Low
